DGA Techniques aéronautiques

EXAMINATION REPORT

N° 16-DGATA-MTI-P1501516001002-DR-F-Â

Following the discovery on 29/07/2015 on a beach on the island of la Réunion of a part from the flight controls (a flaperon), the Tribunal of Grande Instance of Paris (TGI Paris) requested assistance from the DGA techniques aéronautiques (DGA TA) in order to perform examinations on this part.

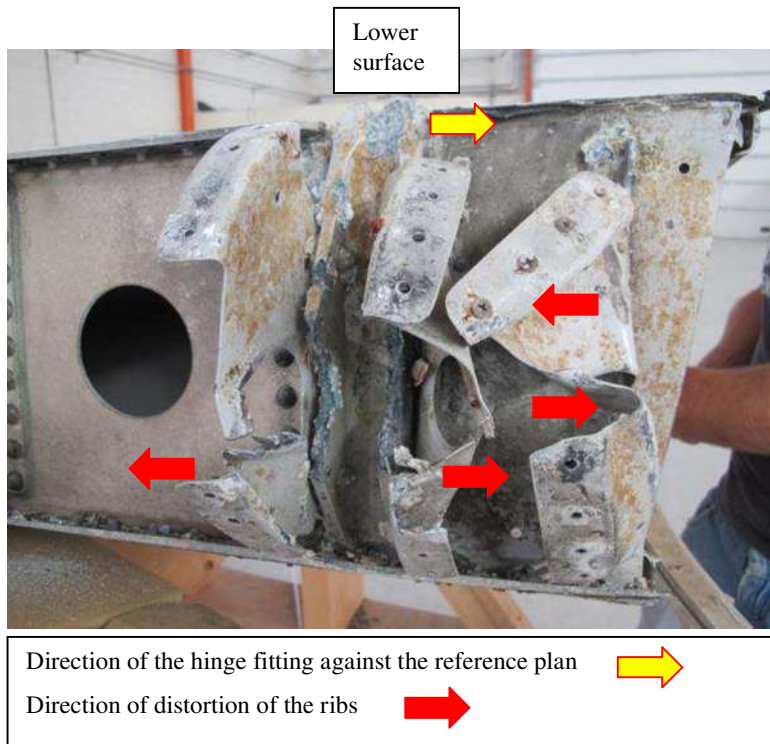
- Distortions of the outboard hinge fitting and of the leading-edge ribs

The leading edge ribs were bent and in places seemed to have been torn by another part. After the visit made to an aircraft, it appeared that the hinge point that allowed the return of the activator at the level of the hinge fitting could be the cause of the tears of the while the ribs could have pressed on the shaft or the body of the activator, which would explain the form of the folds (see plate 43).

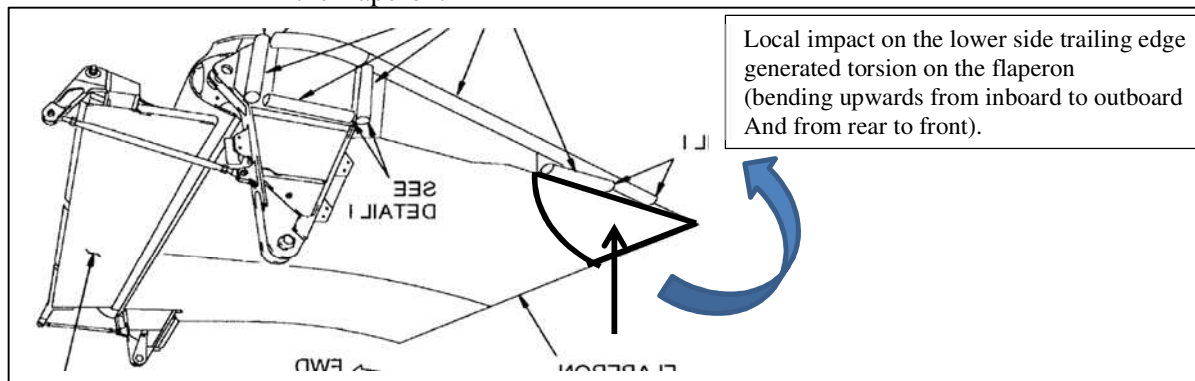
2. The damage being greater on the trailing edge on the inboard side, notably on the lower surface side, it appears that the contact occurred first in this zone. The loads generated, pushing from the lower surface towards the upper surface locally (unlike uniform aerodynamic loading), resulted in a bending load from the rear towards the front as well as of inboard towards outboard. This caused torsion on the flaperon.

- Impact point and torsion loading on the flaperon -

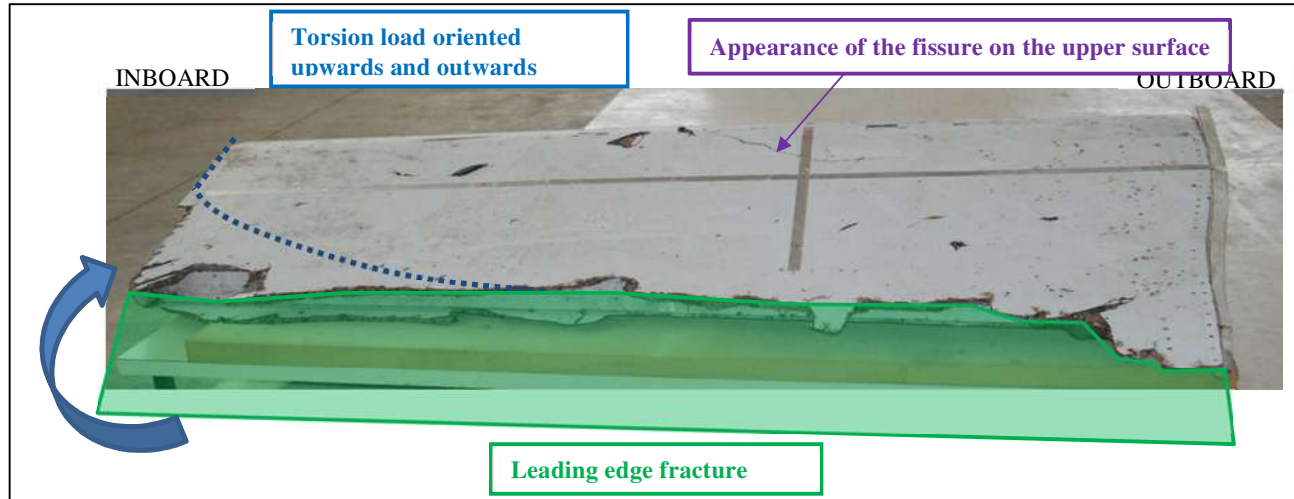
3. This contact led to the disappearance of a large part of the trailing edge, behind the rear spar (trailing edge bending upwards). The crack observed on the upper surface could be a consequence of the loads linked with the torsion that would

have generated bowing near the forward spar and a shearing fracture in more in the centre of the flaperon.

- Fracture of the trailing edge and appearance of the crack on the upper surface-

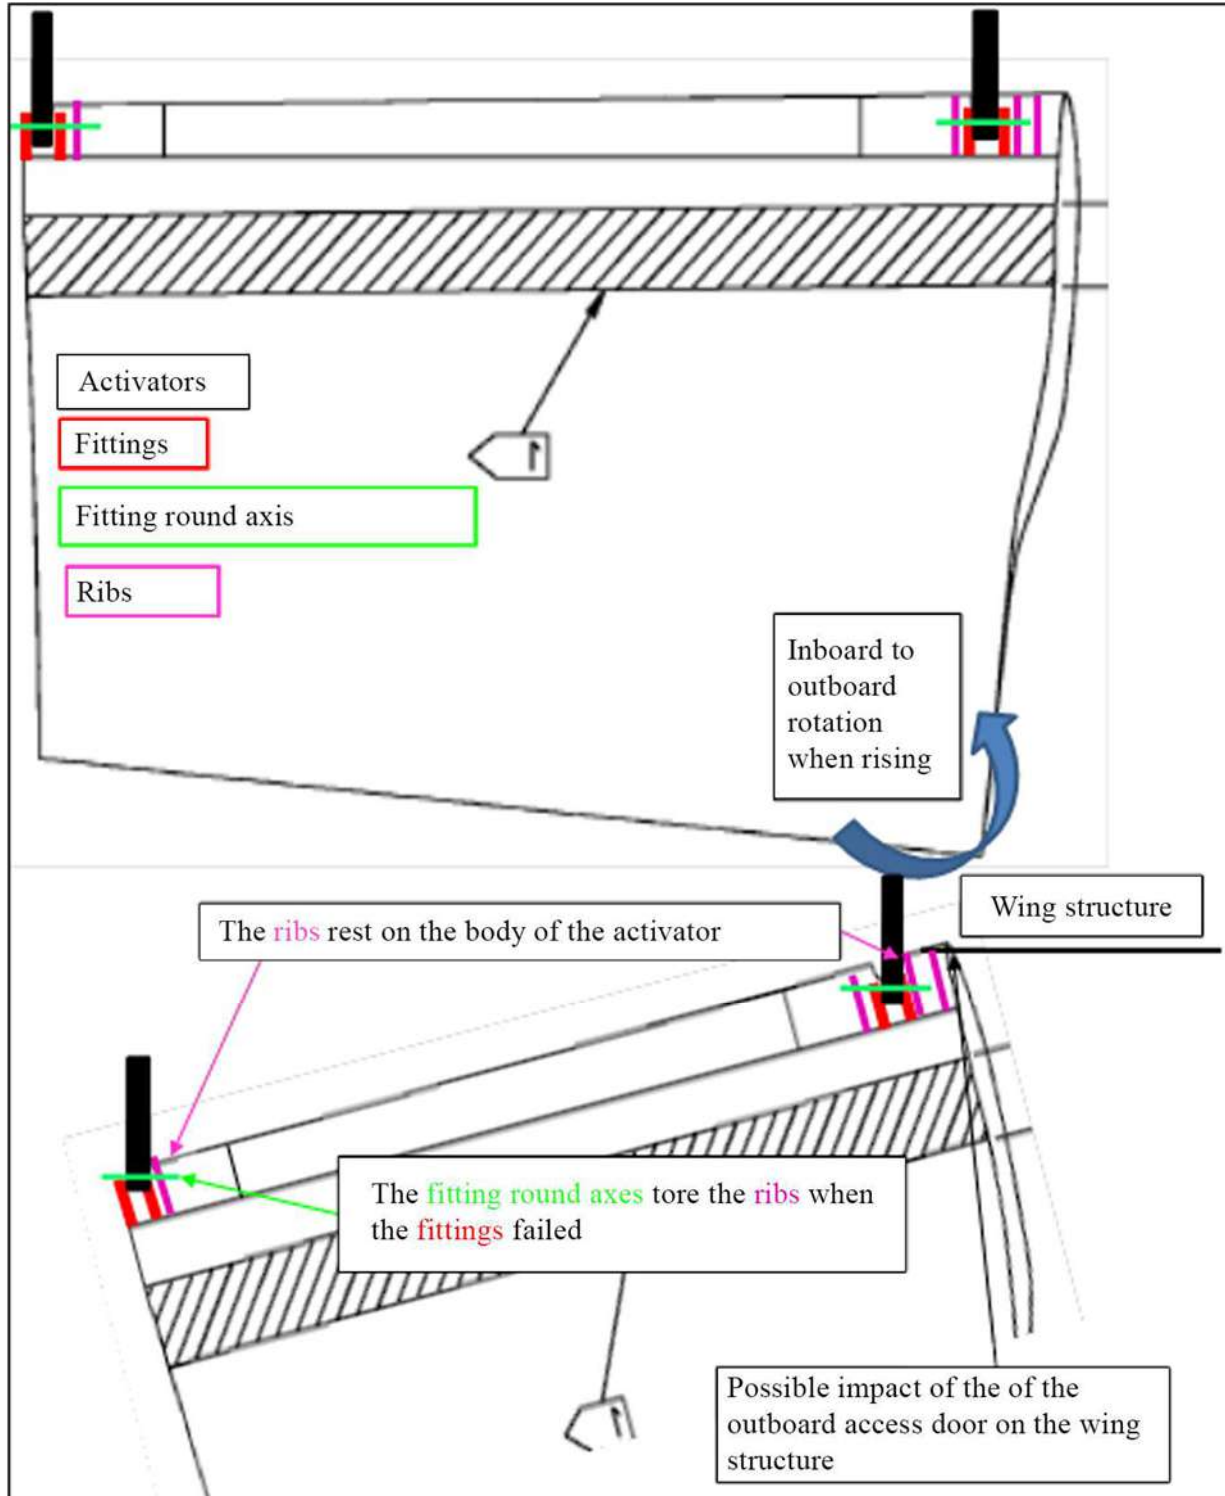
5. The flaperon pivoted from the inside towards the outside around the outboard hinge fitting (anticlockwise direction). This caused the fracture of the lower part of the outboard hinge fitting as well crushing the fairing of leading edge and pushing the of leading edge ribs onto the actuating cylinders, which would explain their being crushed. The inboard then the outboard lugs, which the activators are attached to, broke off and the flaperon detached. The moment when the fracture of the lugs occurred during this sequence is not clearly definable, in particular the fracture of the inboard lug before that of the lower part of the outboard hinge fitting.

- Ribs and lugs fracture damage sequence: separation of the flaperon -

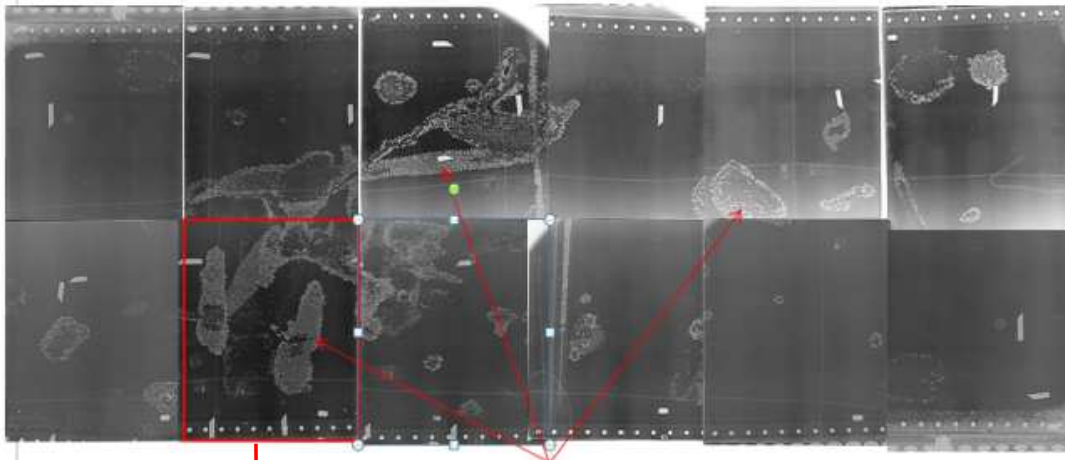
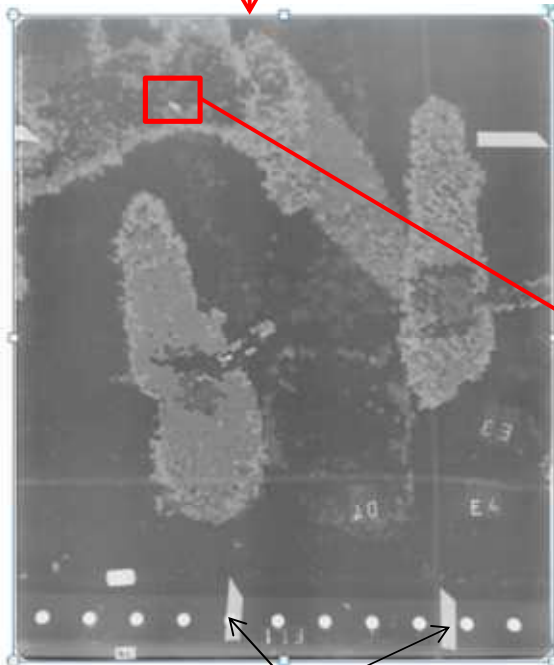
Planche 15 : X-rays of the flaperon

The lightest zones on the x-rays corresponded to salt deposits following the penetration by sea salt into the cracks in the composite panel (see §9.1 for the detail of the flaperon's structure).

The lightest zones correspond to salt deposits following sea water penetration in the cracked composite

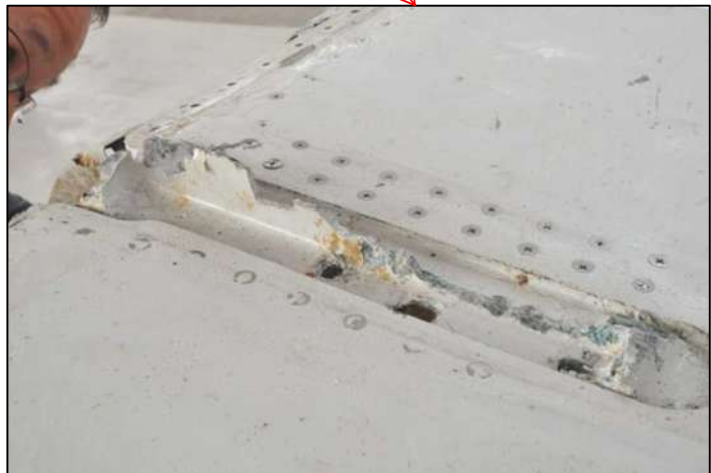
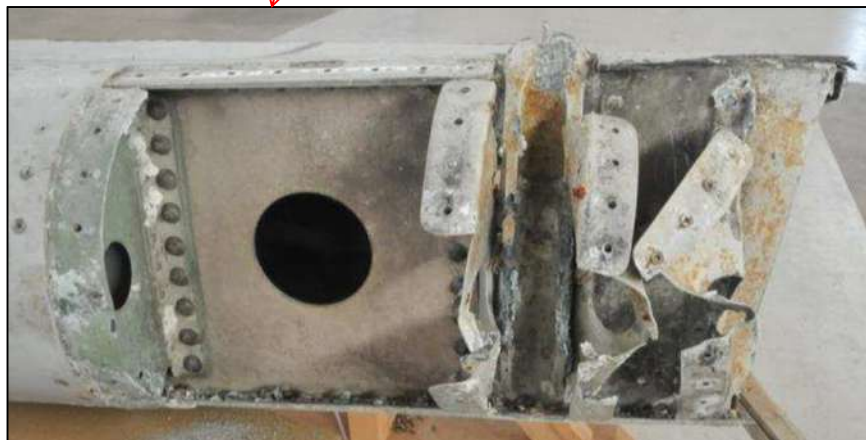
Planche 24 : Hinge fitting on the outboard side

Plate n°24 shows the two fractures on the outboard flaperon hinge fitting (lower surface and leading edge sides after disassembly of the panel).

Lower surface fracture

Leading edge fracture

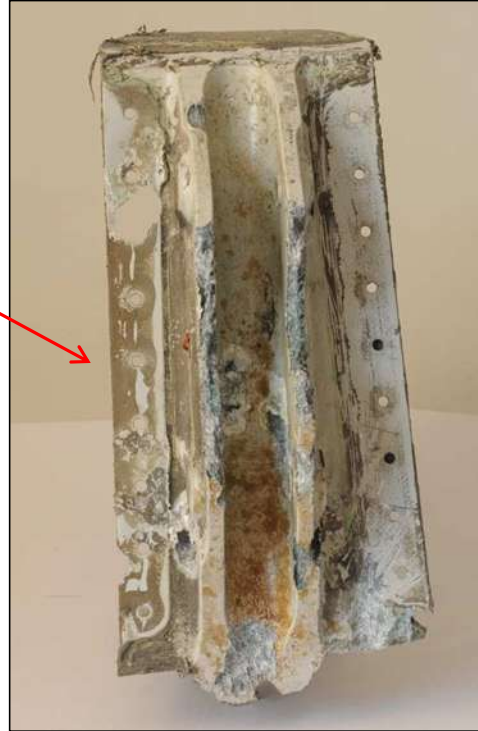
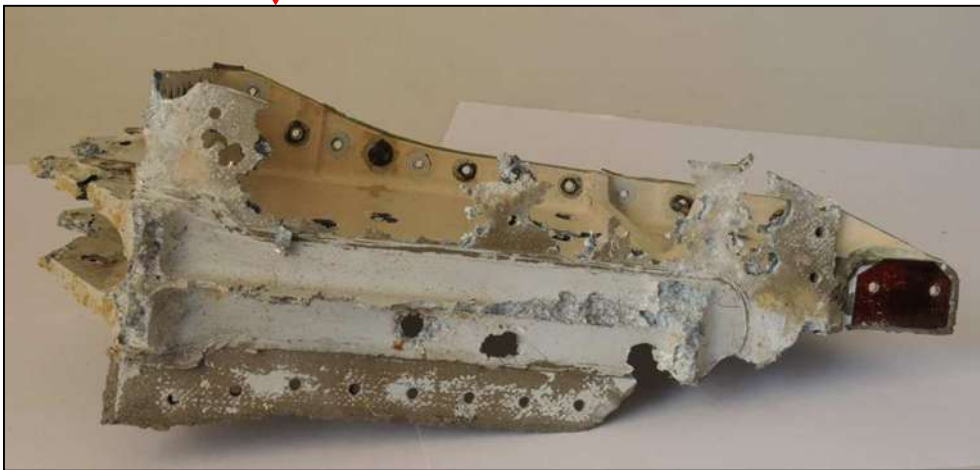
Outboard hinge fitting
dissassembled

Leading edge fracture

Lower surface
fracture

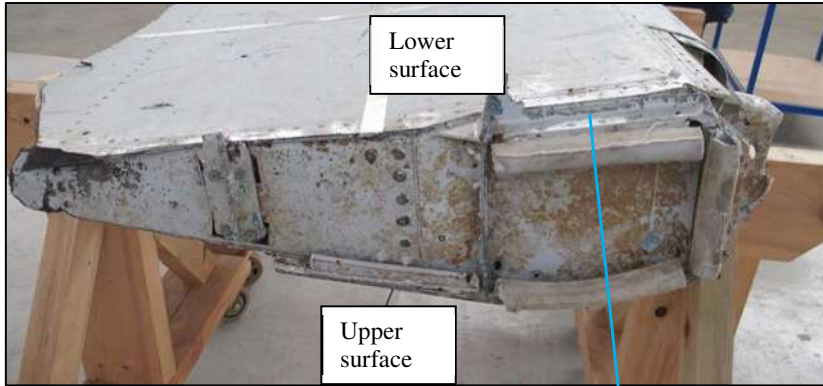
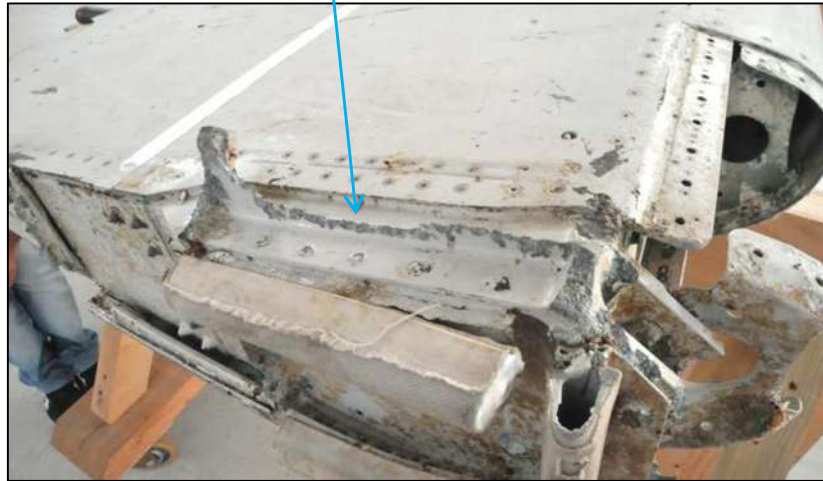
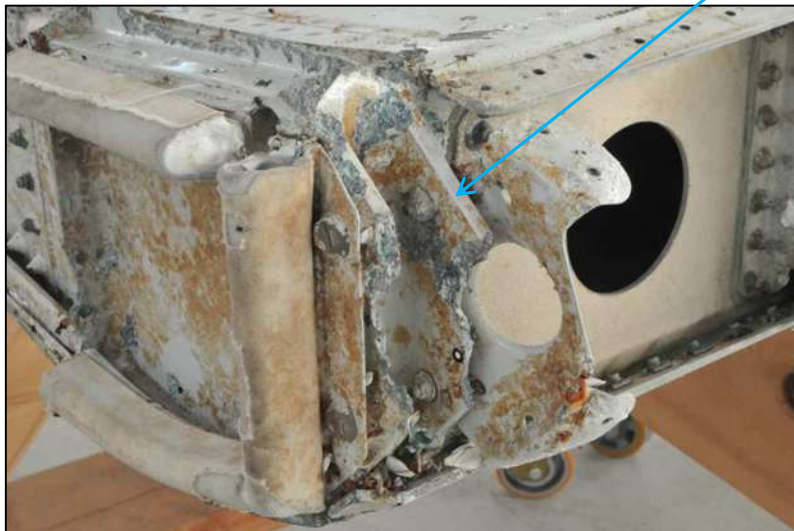
Planche 32 : **Inboard hinge fitting**

Lower surface side hinge fitting fracture

Leading edge side hinge fitting fracture

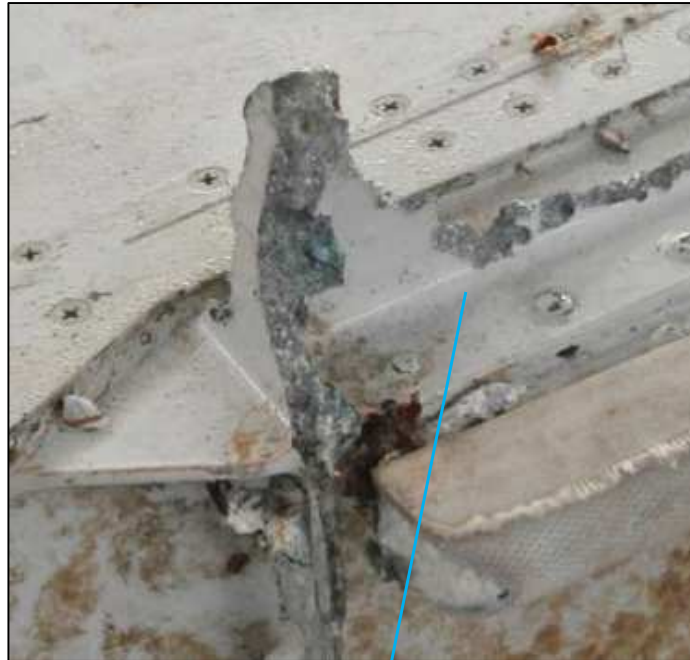
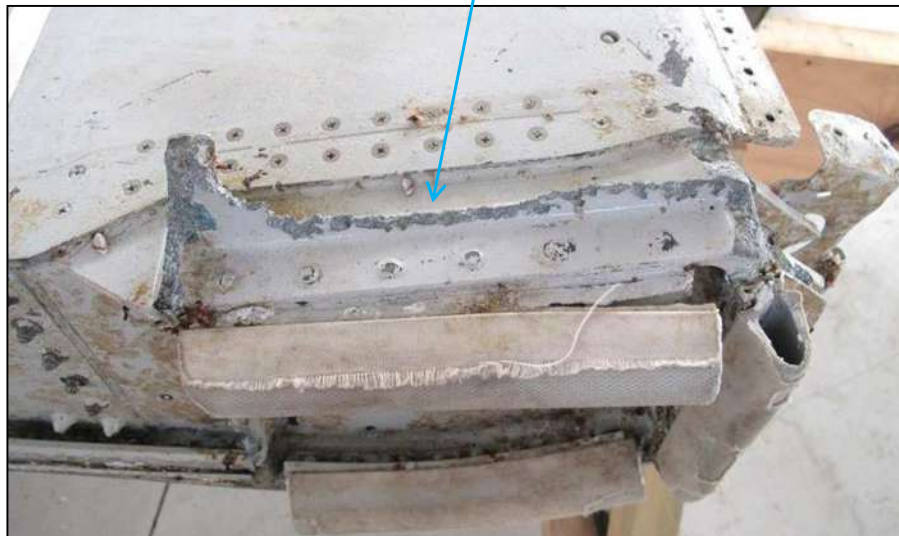
Planche 34 : **Inboard hinge fitting**

Lower surface side hinge
fitting fracture

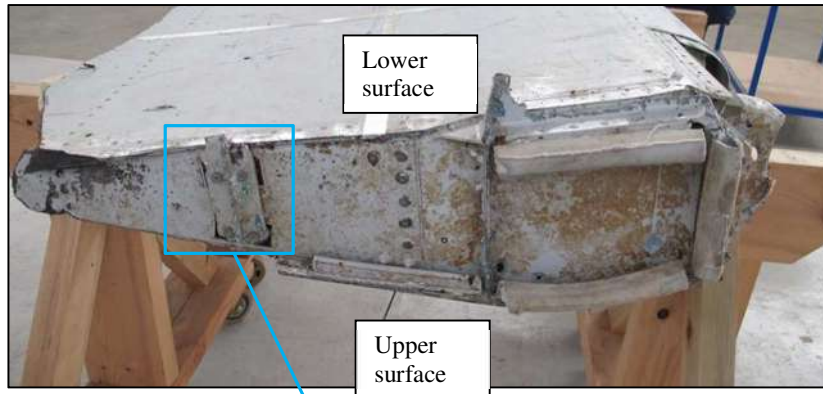
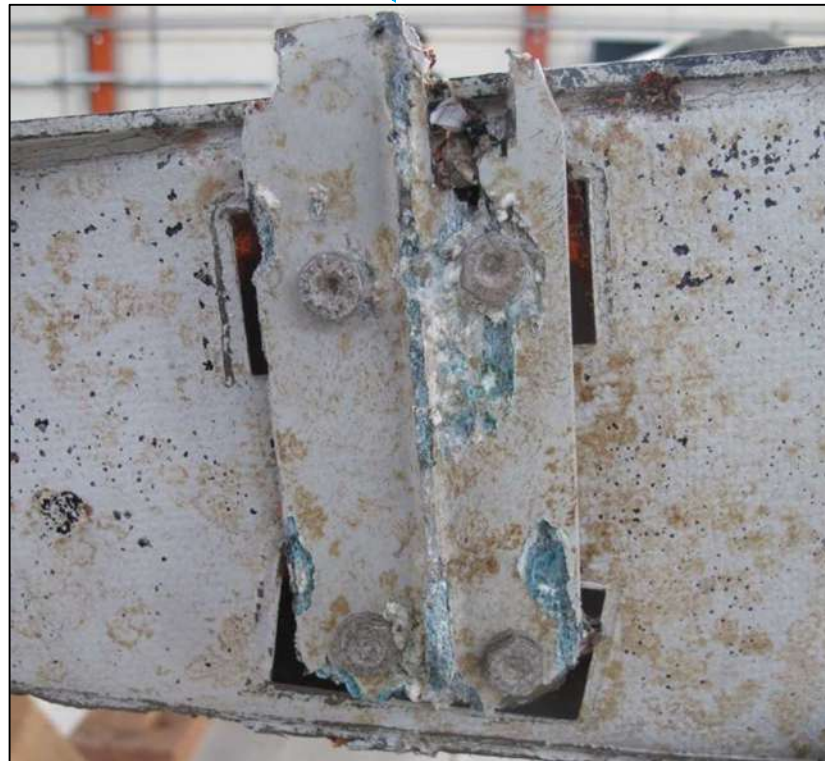
Planche 35 : **Cowling attachment on the inboard side**

Attachment fracture

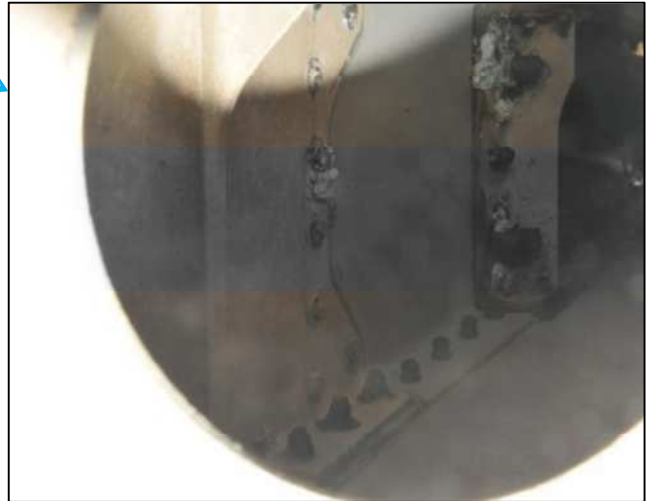
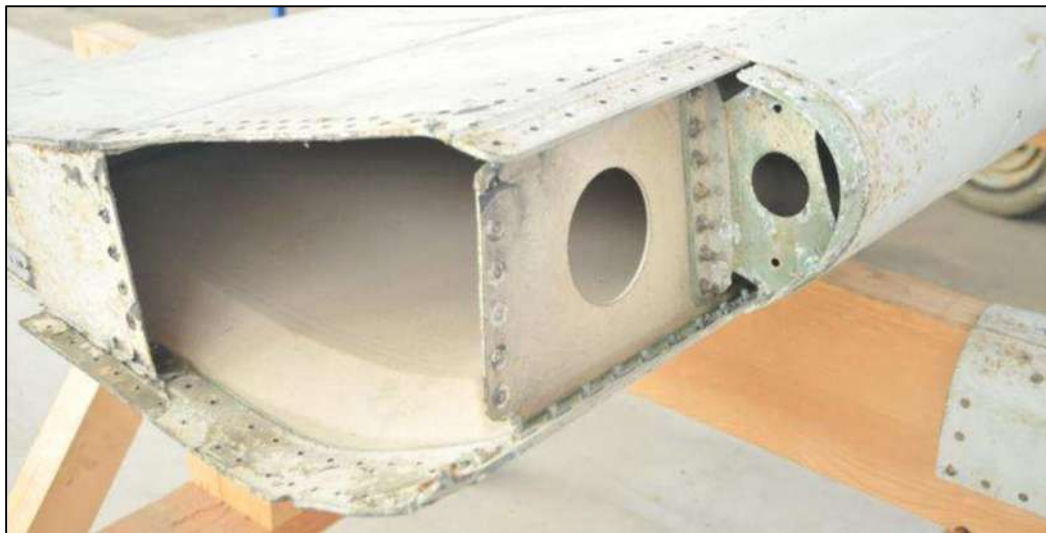
Planche 36 : Flaperon after disassembly of the hinge fitting on the inboard side

**Lower surface side hinge
fitting fracture**

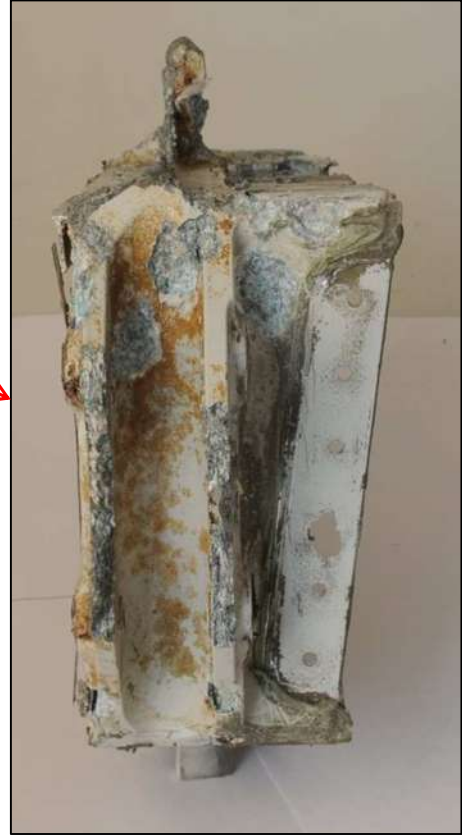
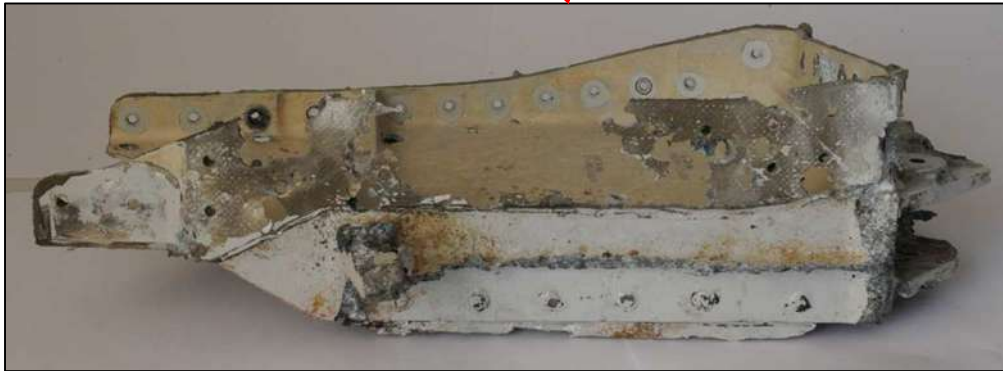
Inboard hinge fitting
disassembled

Leading edge fracture

Lower surface
fracture

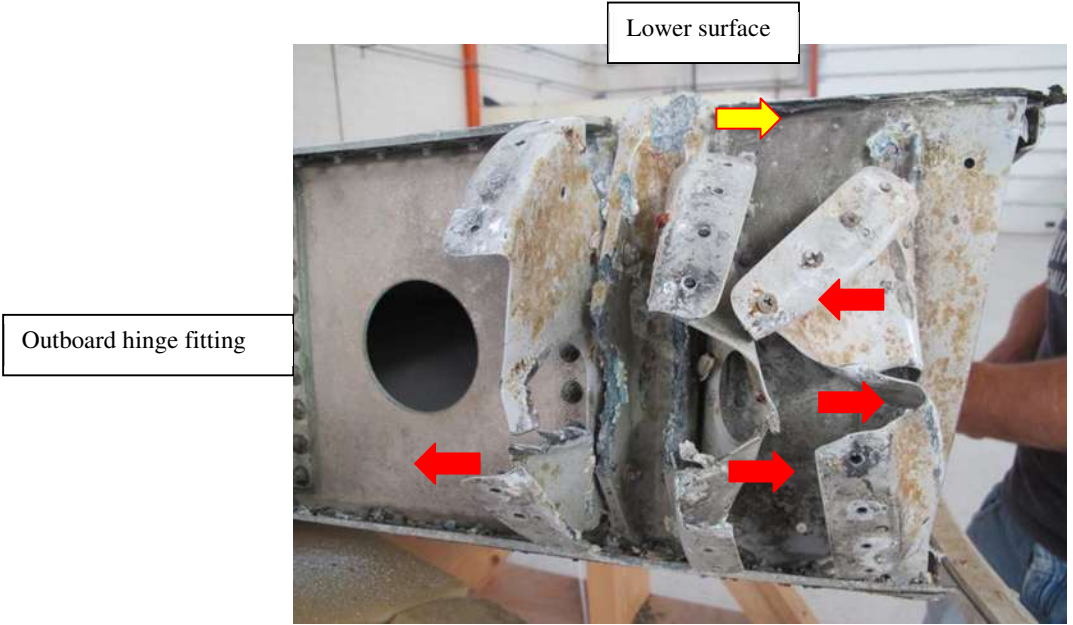
Planche 43 : Summary of the distortions and fractures of the leading edge hinge fittings and ribs

Plate n°42 summarizes the direction of the distortions of the hinge fittings with those noted on the ribs close to the hinge fittings. All of these distortions were correlated and were going in the inboard – outboard direction. The image below shows an example of these observations for the outboard side.

Orientation of hinge fitting in relation to reference plan →

Direction of distortions →

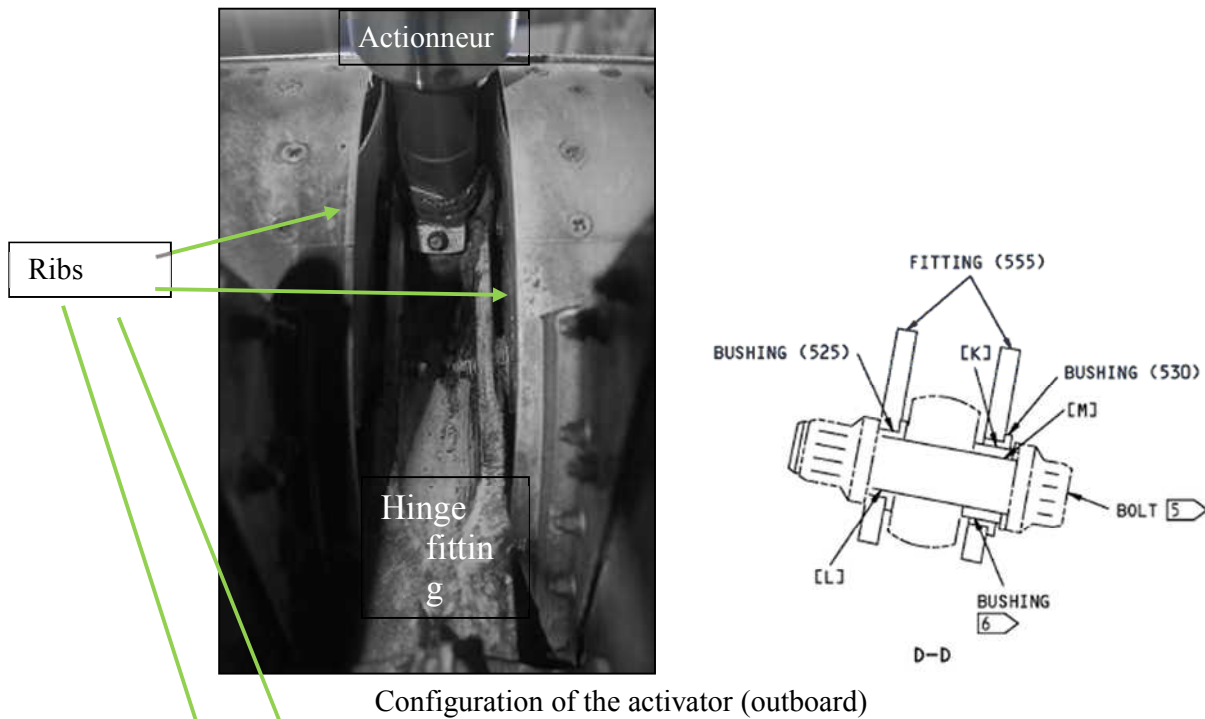
Planche 44 : **Possible explanation of the distortions and fractures of the outboard side leading edge ribs**

Configuration of the activator (outboard)

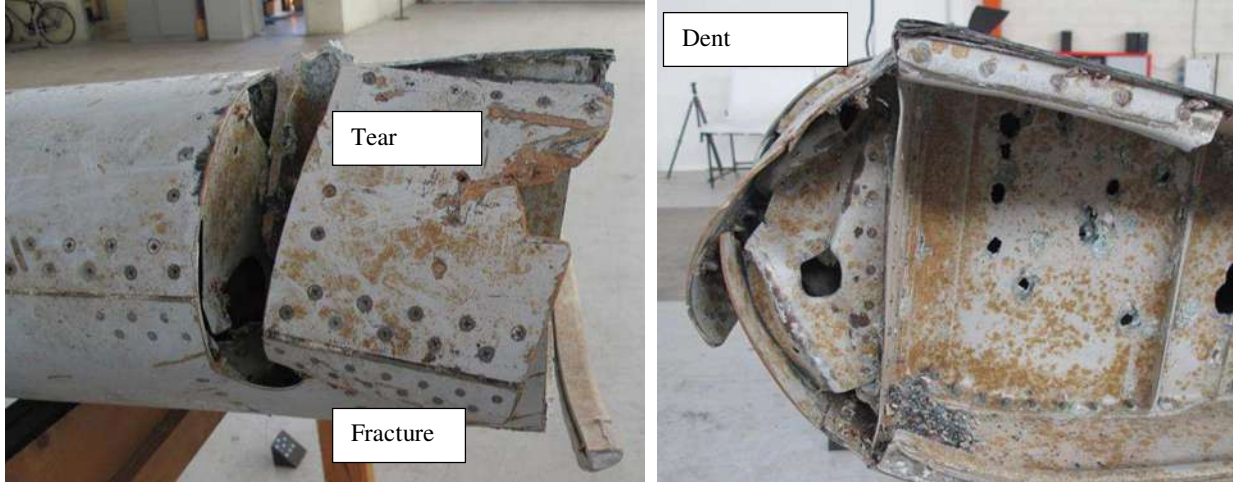
Planche 46 : Damage at the level of the leading edge access doors

Dent and tear on the access door on the outboard side

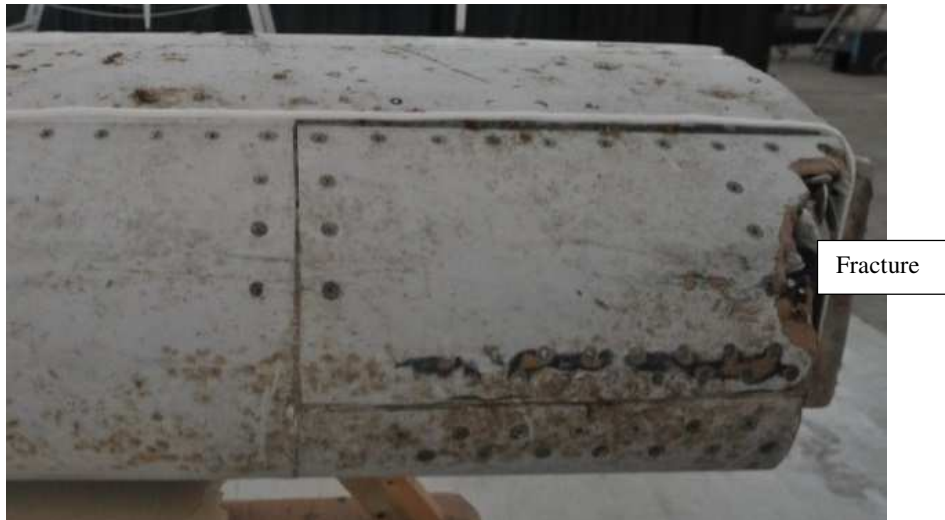
Fracture of the access door on the inboard side

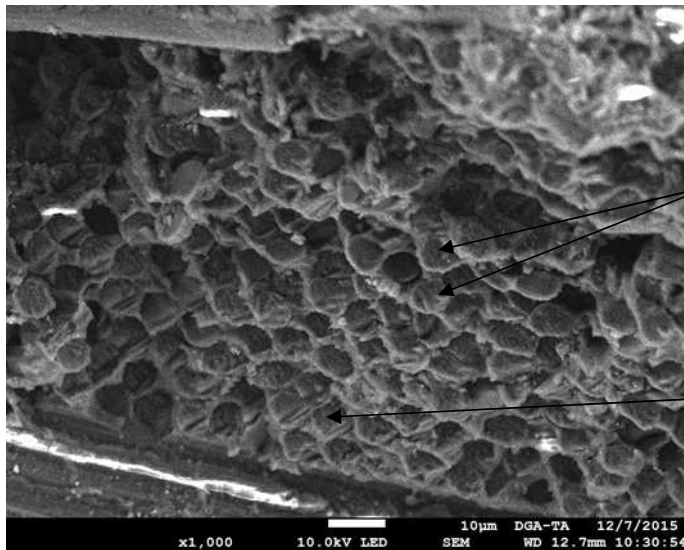
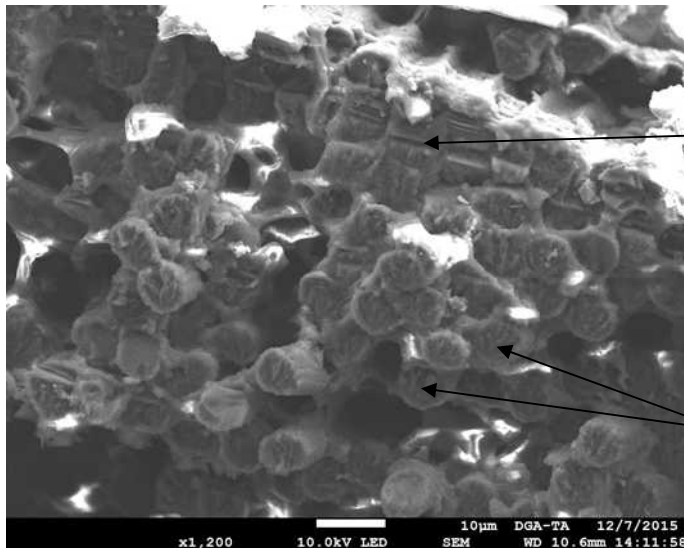
Planche 51 : Lower surface: irregular fracture on trailing edge – SEM Examination

Inner skin : radiating form characteristic of a traction fracture

Inner skin: steps characteristic of a compression fracture

All of the fracture surfaces on the inner skin: majority in compression

All of the fracture surfaces on the outer skin: majority in traction.

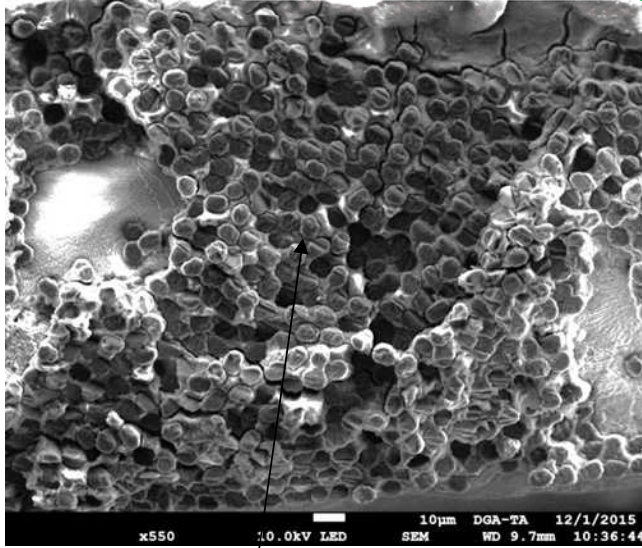
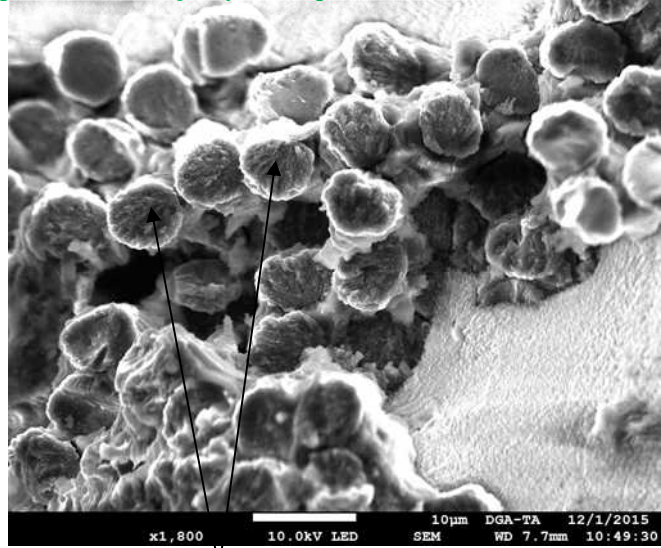
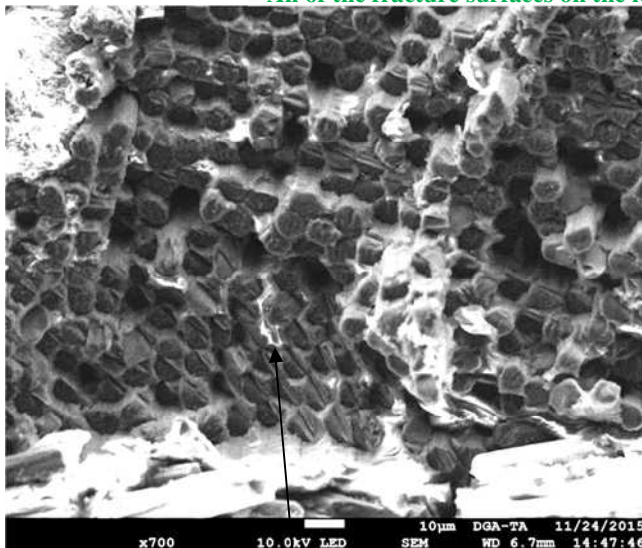
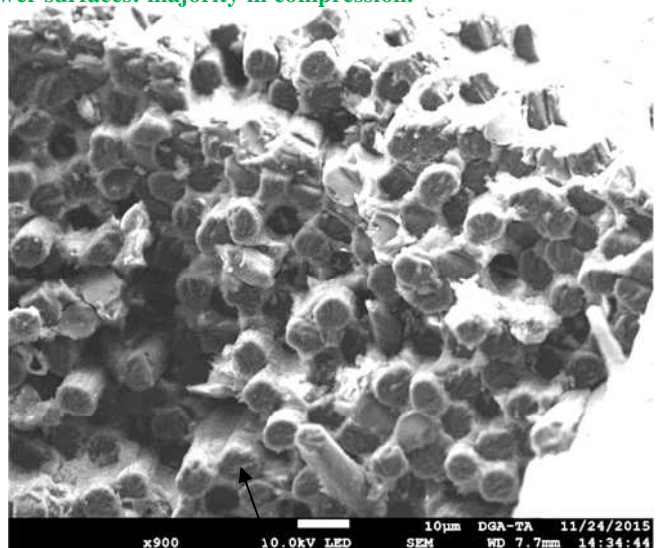
Planche 53 : Lower surface: straight fracture on trailing edge – SEM Examination

All of the fracture surfaces on the upper surfaces: majority in compression.

Upper layers : steps characteristic of a compression fracture

Lower layers: radiating form characteristic of a traction fracture

All of the fracture surfaces on the lower surfaces: majority in compression.

Lower layers: steps characteristic of a compression fracture

Upper layers: radiating form characteristic of a traction fracture

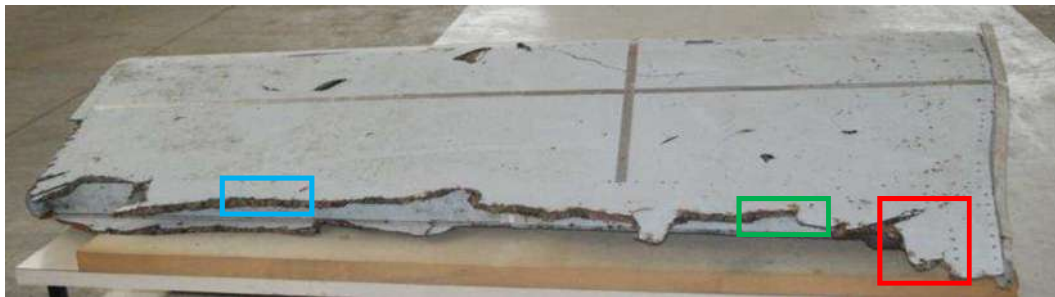
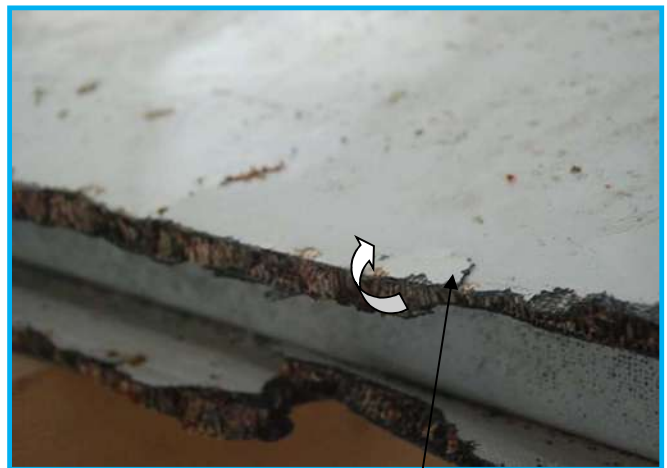
Planche 55 : Upper surface: fracture on trailing edge

Orientation of material upwards

Regular fracture, without protruding fibres

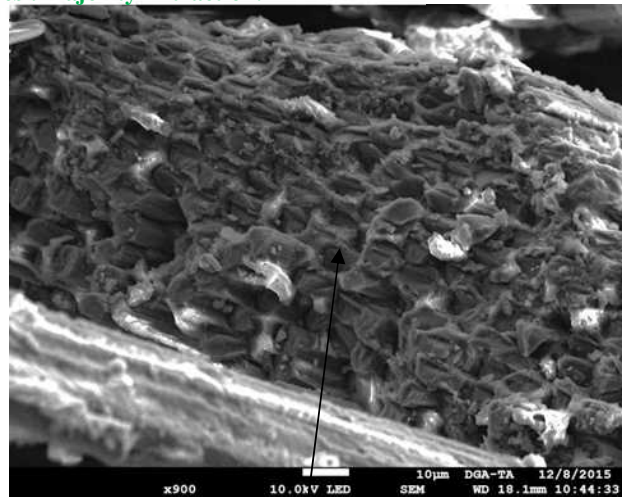
Planche 56 : Upper surface: fracture on trailing edge – SEM examination

Outer skin : surfaces characteristic of a traction fracture

Outer skin: steps characteristic of a compression fracture

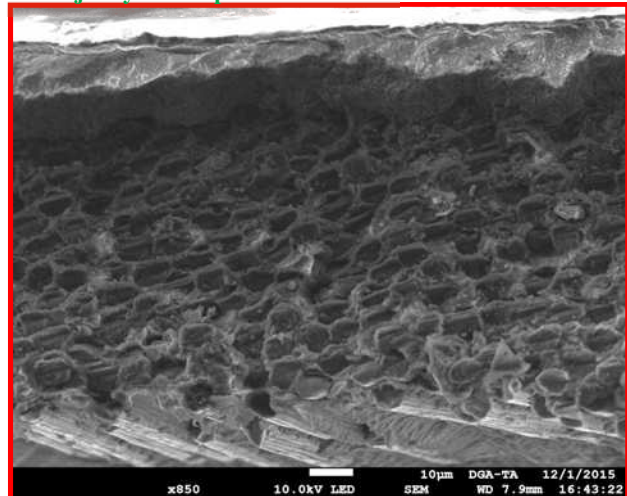
Near paint : surfaces characteristic of traction fracture

All surfaces honeycomb side: majority in compression.

Near honeycomb : steps characteristic of compression fracture

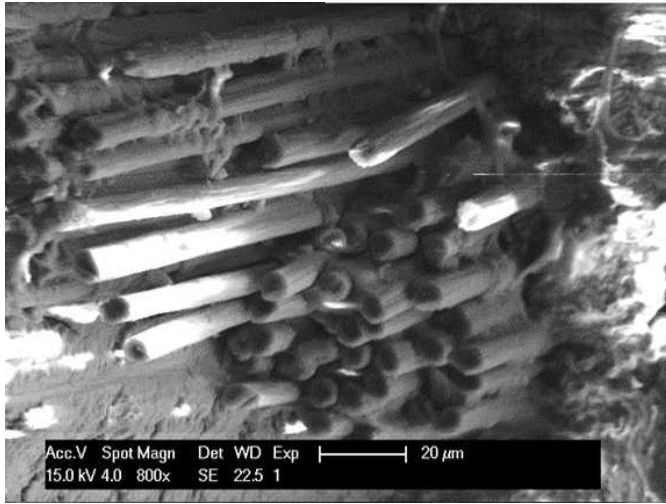
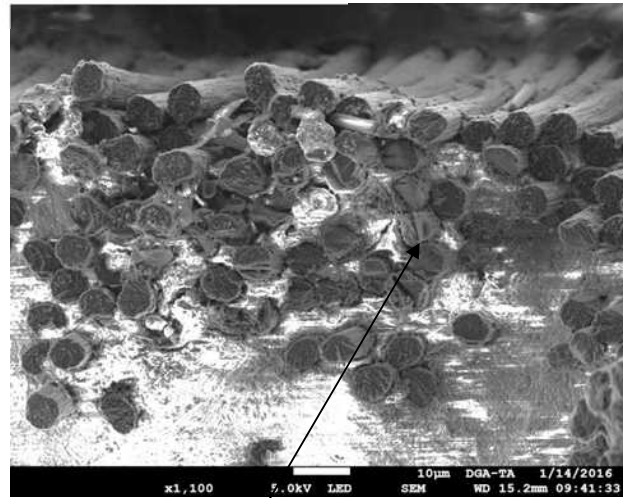
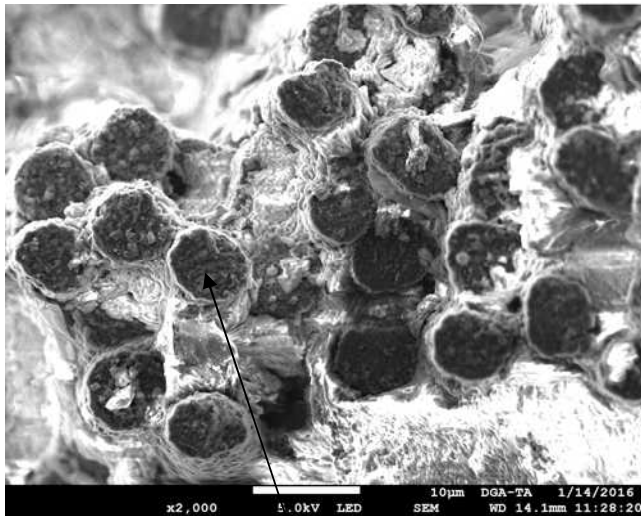
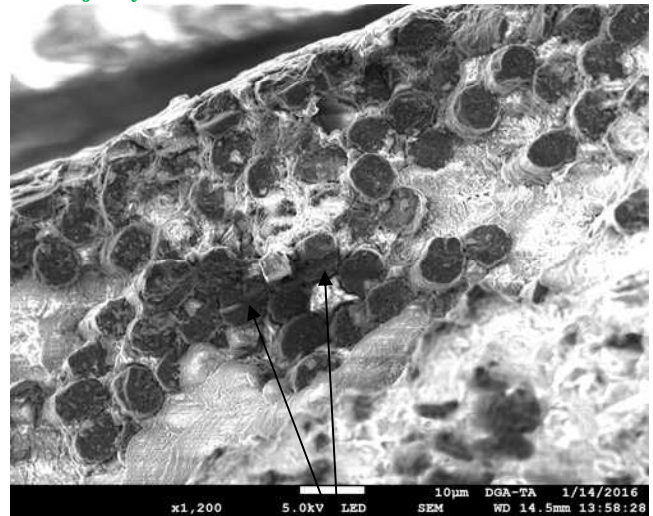
Planche 61 : Upper surface: observation of the crack in a protruding part (2/2)

All of inner skin fracture surfaces : majority in traction .

Outer skin: fracture surfaces characteristic of traction fracture

Outer skin: some fibres in compression

All of inner skin fracture surfaces : majority in traction

Peau skin: radiating form : fracture surfaces characteristic of traction:

Inner skin : some fibres in compression

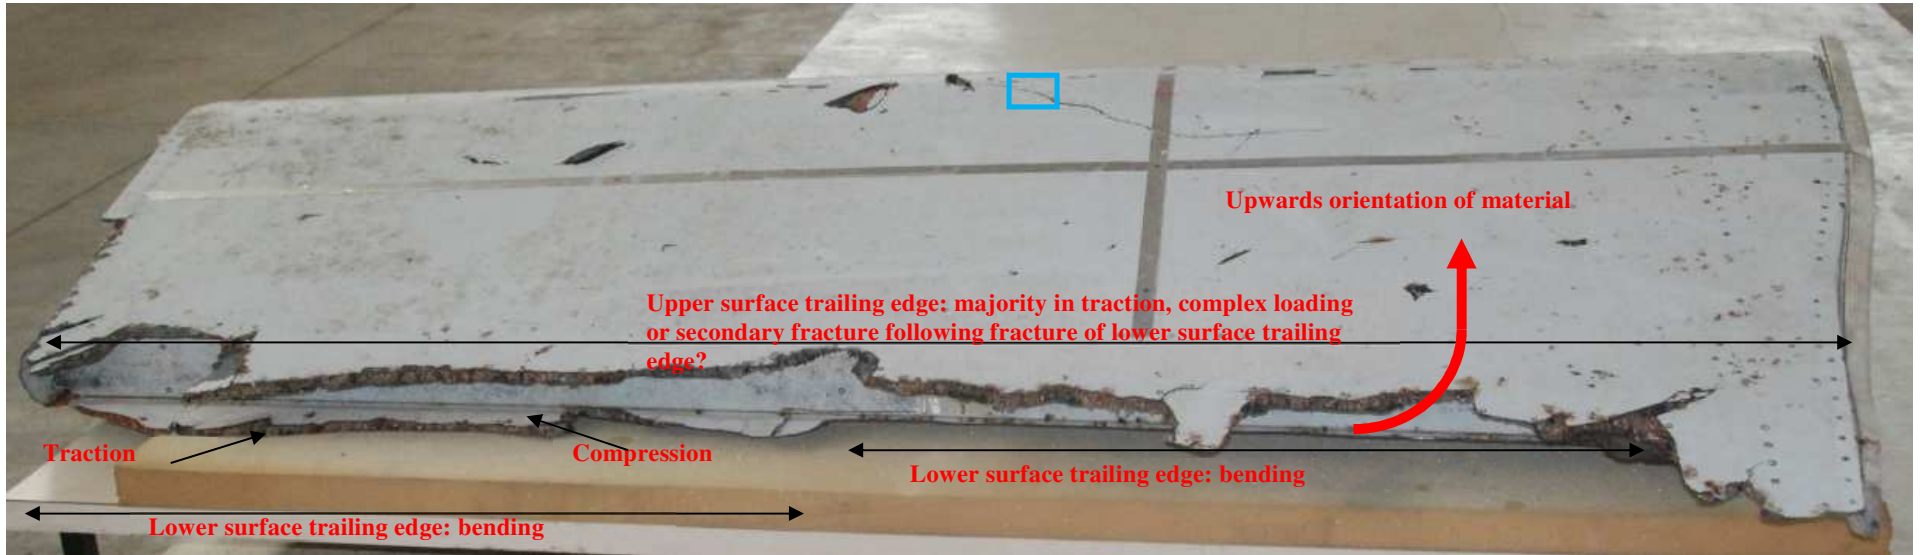
Planche 62 : Summary of the deductions made based on the observations and examinations on the composite structure of the flaperon

Non-protruding crack : **bending**
fracture : **skin bowing.**
