DGA Techniques aéronautiques

EXAMINATION REPORT

N° 16-DGATA-MTI-P1501516001002-DR-F-Â

Following the discovery on 29/07/2015 on a beach on the island of la Réunion of a part from the flight controls (a flaperon), the Tribunal of Grande Instance of Paris (TGI Paris) requested assistance from the DGA techniques aéronautiques (DGA TA) in order to perform examinations on this part.

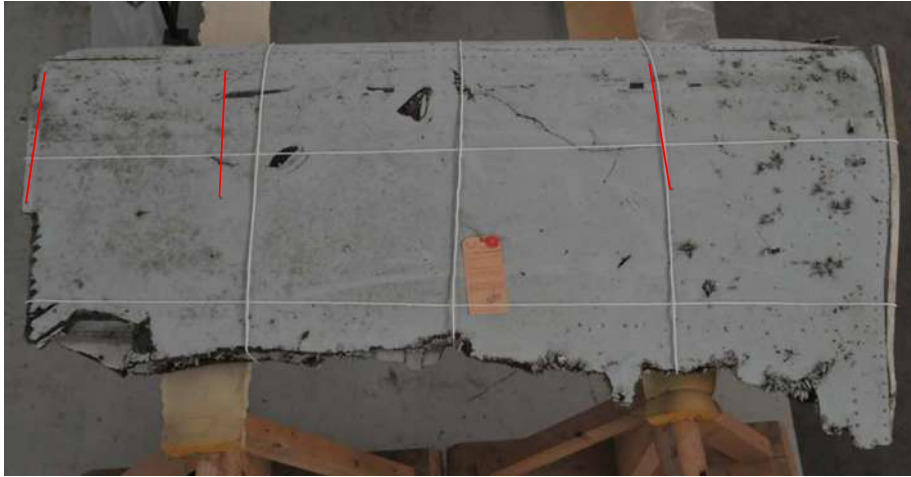
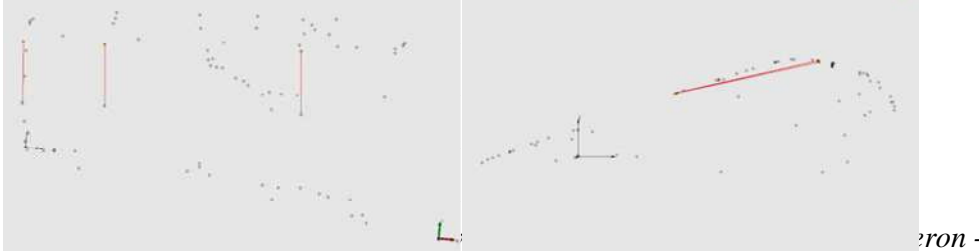
The first measurement on 06 August 2015, presented in appendix 6, only related to the upper surface and the ribs to prevent any manipulation of the part that could be damaging for the biological examination. It showed the absence of any significant distortion of the flaperon as can be seen in the illustration below.

The 3D measurement shows that the three lines measured remained aligned on the upper surface and appear to be together seen from the side, indicating the absence significant distortion on the part

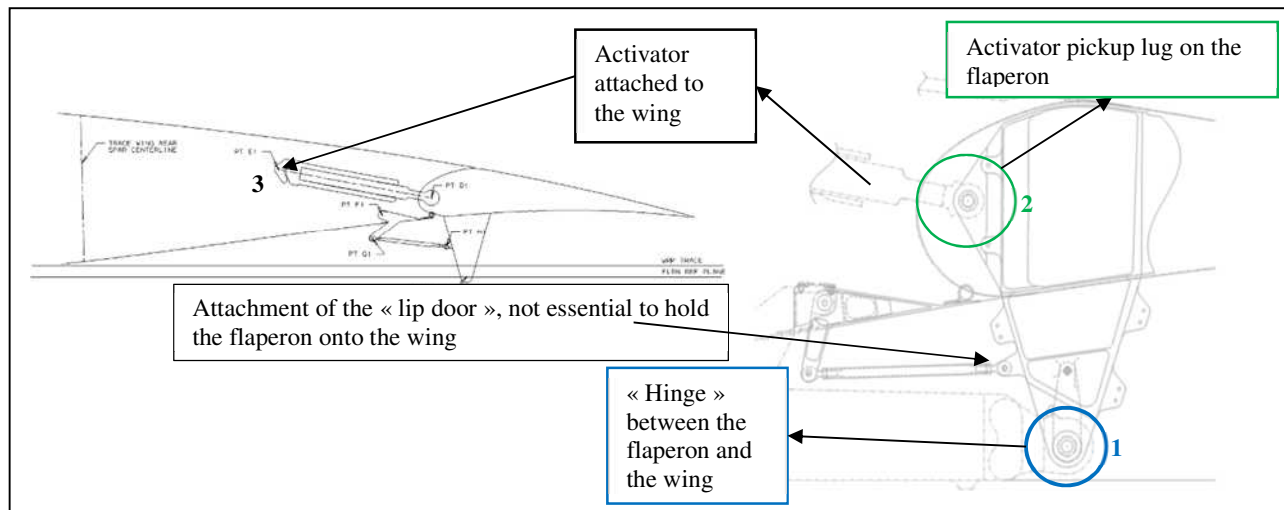
- Flaperon attachments -

The number of critical flaperon attachment points can thus be reduced to three on each side (see diagram above) since the lower wing lugs and flaperon constitute a hinge by being attached to a single hinge point. The loss of one of these attachment points is likely to lead to the separation of the flaperon by causing a possible chain-reaction fracture of the other attachment points.

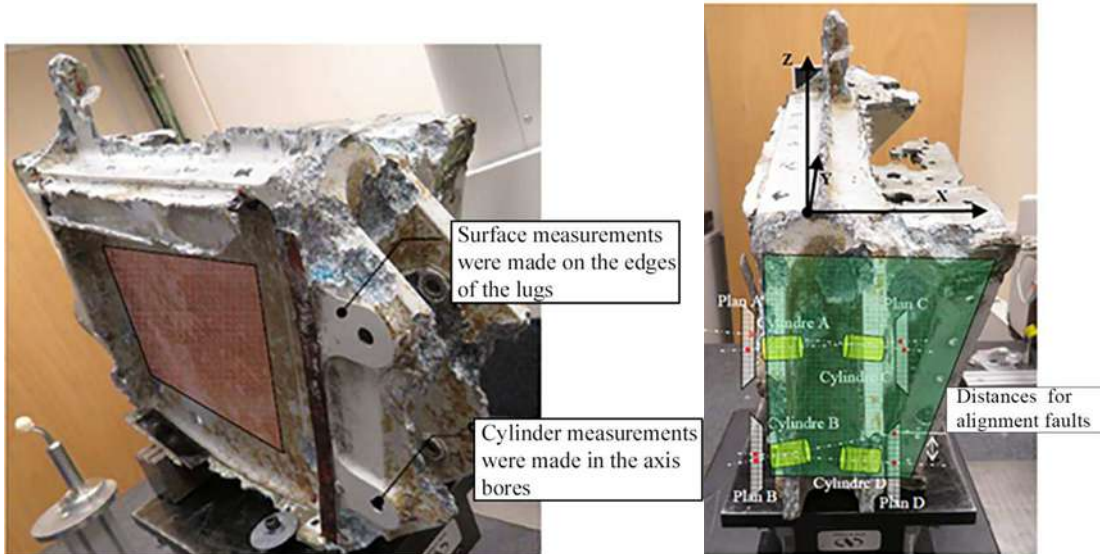
- Creation of references for the measurements and measurements on the inboard hinge fitting -

In the absence of any plans of the hinge fittings and for the purpose of measuring possible overall distortion of the latter, references were made by the metrology department based on non-distorted parts, as illustrated below, on the inboard hinge fitting. The distortions were thus measured against these references and not against the plans of the part. The complete metrology report is in appendix n°10.

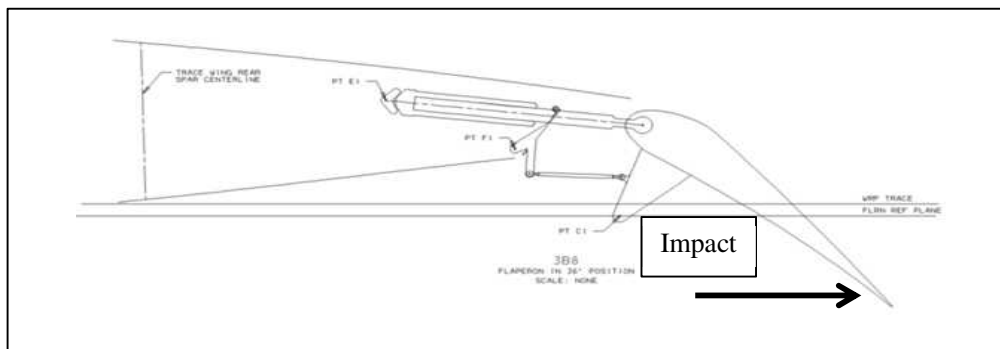
- Presumed position of the flaperon on impact -

1. Considering an impact with water as likely, and considering the damage observed, it seems that the flaperon must have been deflected at the time of the impact,

2. The damage being greater on the trailing edge on the inboard side, notably on the lower surface side, it appears that the contact occurred first in this zone. The loads generated, pushing from the lower surface towards the upper surface locally (unlike uniform aerodynamic loading), resulted in a bending load from the rear towards the front as well as of inboard towards outboard. This caused torsion on the flaperon.

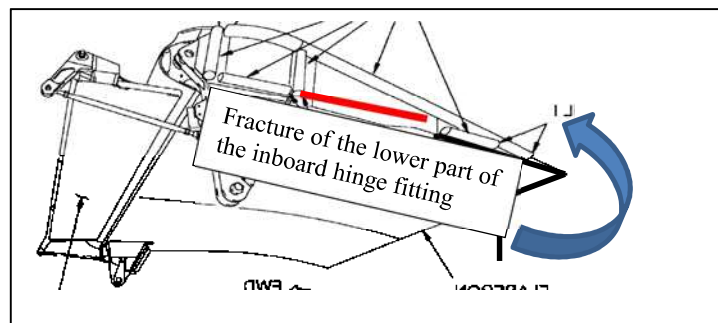
- Fracture of the lower part of the inboard hinge fitting -

4. Almost simultaneously, this torsion from inboard towards outboard and from the rear to the front broke off the lower part of the inboard hinge fitting, not designed for this type of load.

5. The flaperon pivoted from the inside towards the outside around the outboard hinge fitting (anticlockwise direction). This caused the fracture of the lower part of the outboard hinge fitting as well crushing the fairing of leading edge and pushing the of leading edge ribs onto the actuating cylinders, which would explain their being crushed. The inboard then the outboard lugs, which the activators are attached to, broke off and the flaperon detached. The moment when the fracture of the lugs occurred during this sequence is not clearly definable, in particular the fracture of the inboard lug before that of the lower part of the outboard hinge fitting.

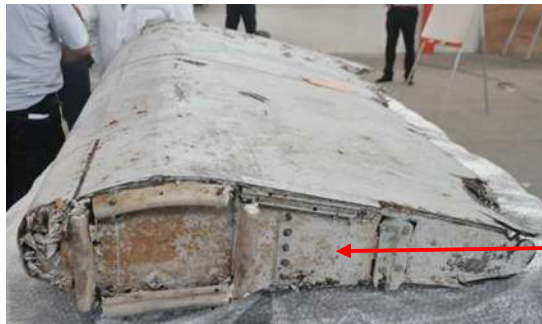
Inboard side

Missing identification plate

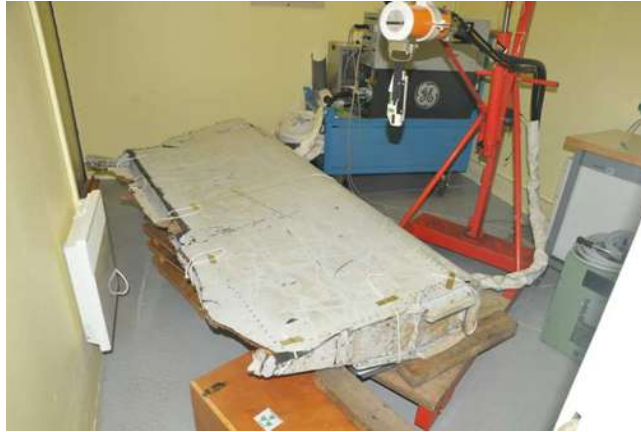
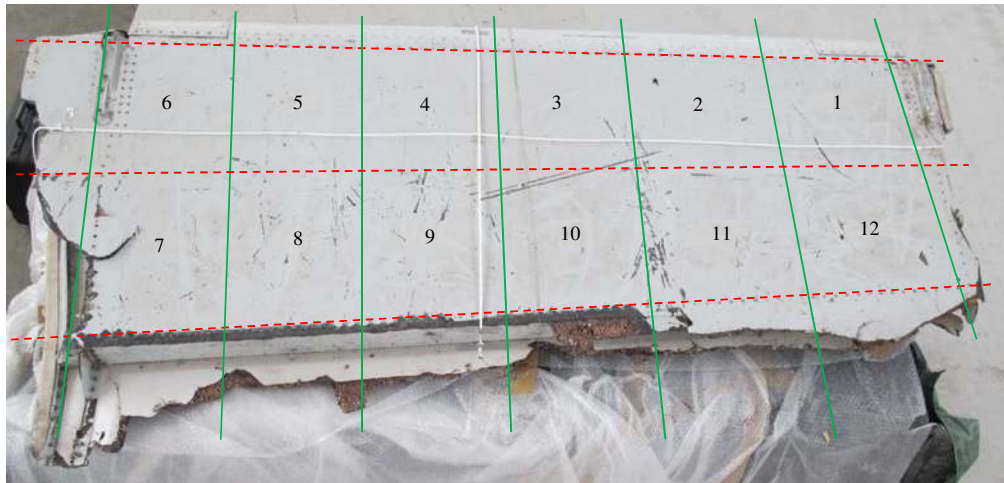
Planche 14 : **X-rays of the flaperon – localisation of the zones x-rayed**

RX x-ray area

X-ray zones

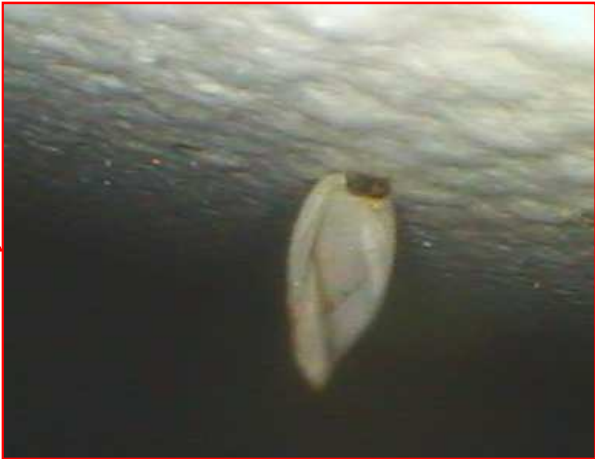
Boroscope of the zone: presence of a crustacean inside the flaperon

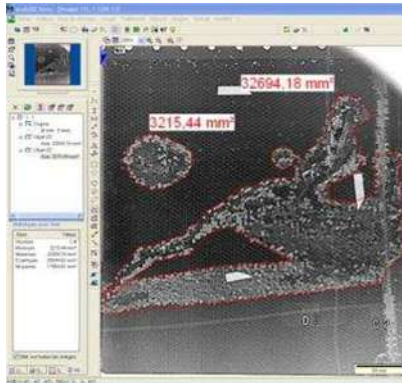
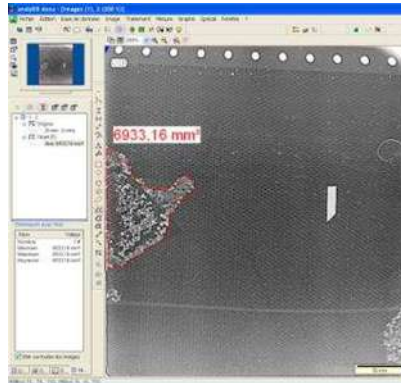
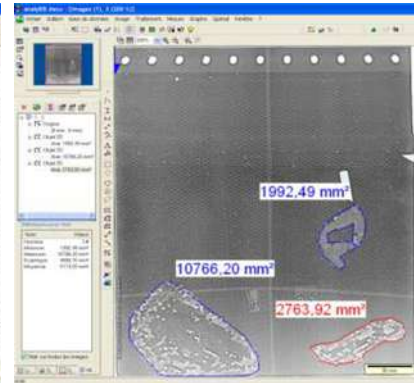
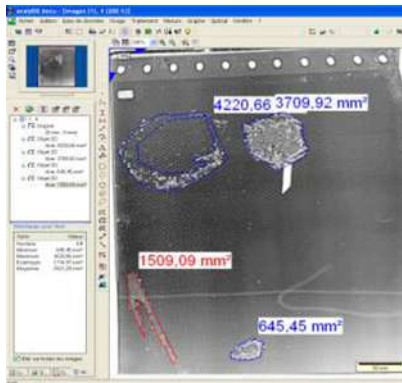
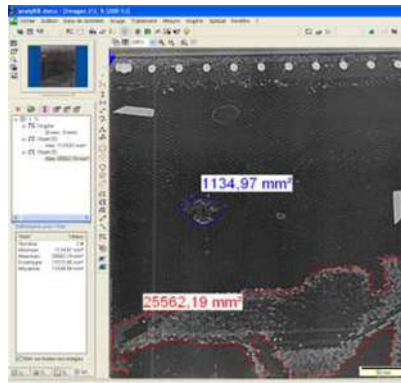
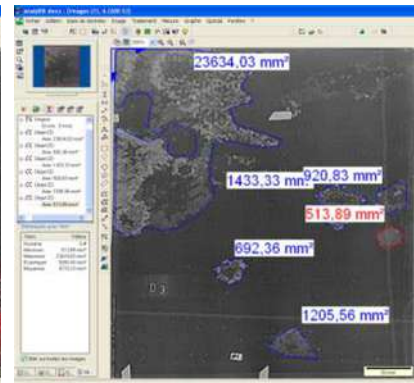
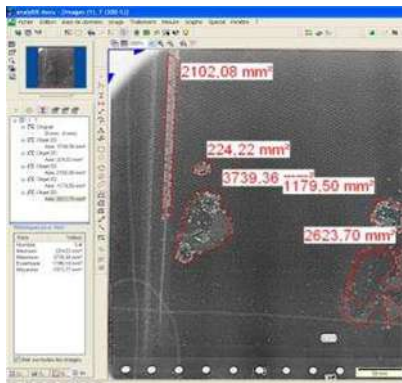
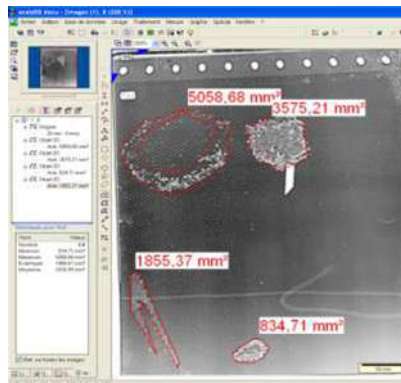
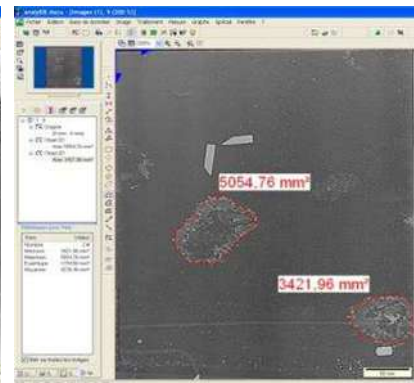
Planche 16 : Area of the zones covered in salt

Total area = 153217 mm² (0.153 m²)

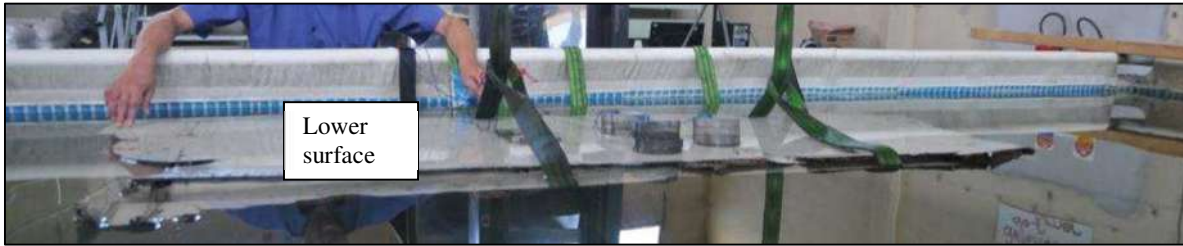
Planche 22 : Buoyancy test

The effective weight to immerse the flaperon completely was 37 kg (41kg –Archimedes buoyancy on weights).

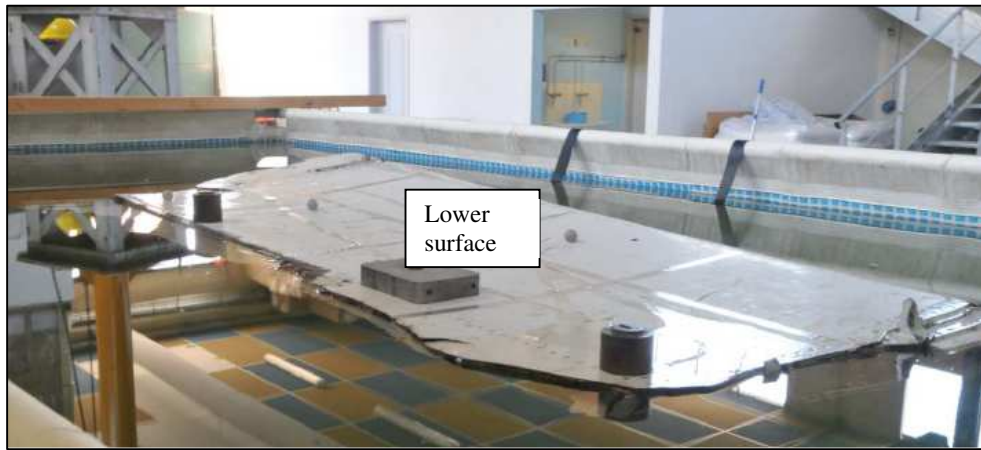
The added weight, which did not touch the water and was thus effective, to immerse the lower surface trailing edge upwards was 13.5 kg.

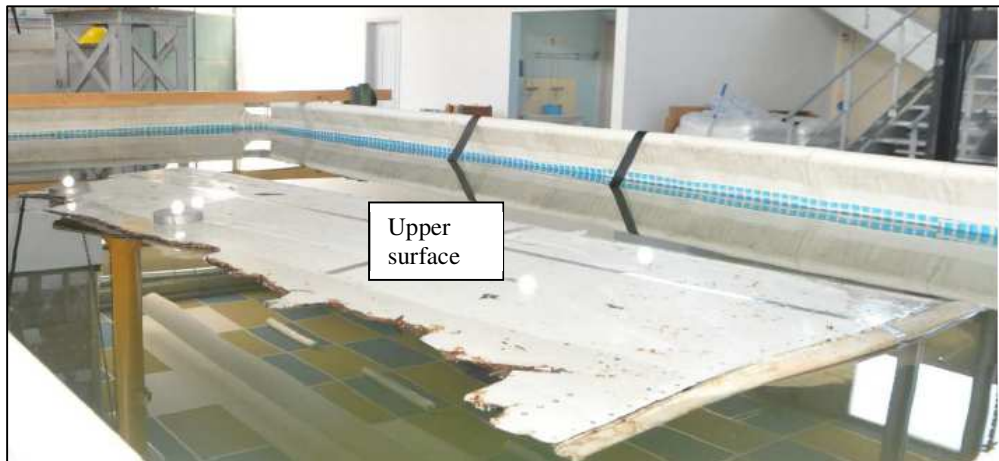
The added weight, which did not touch the water and was thus effective, to immerse the upper surface trailing edge upwards was 5 kg

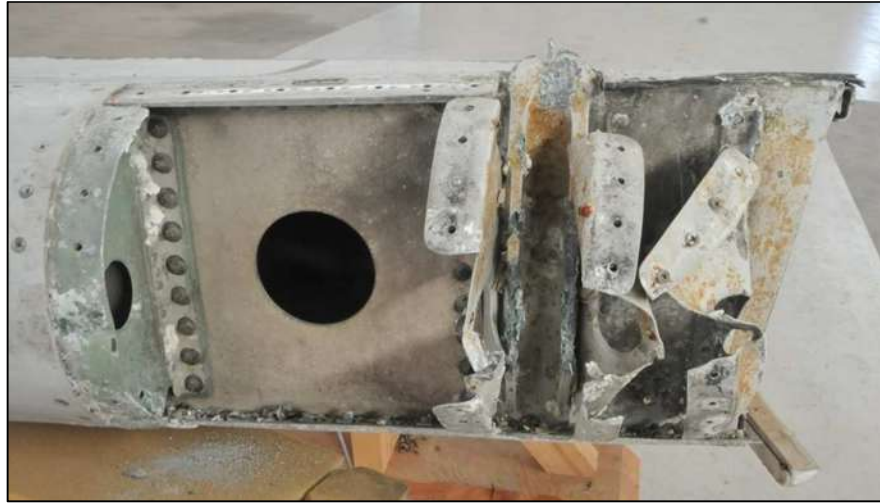
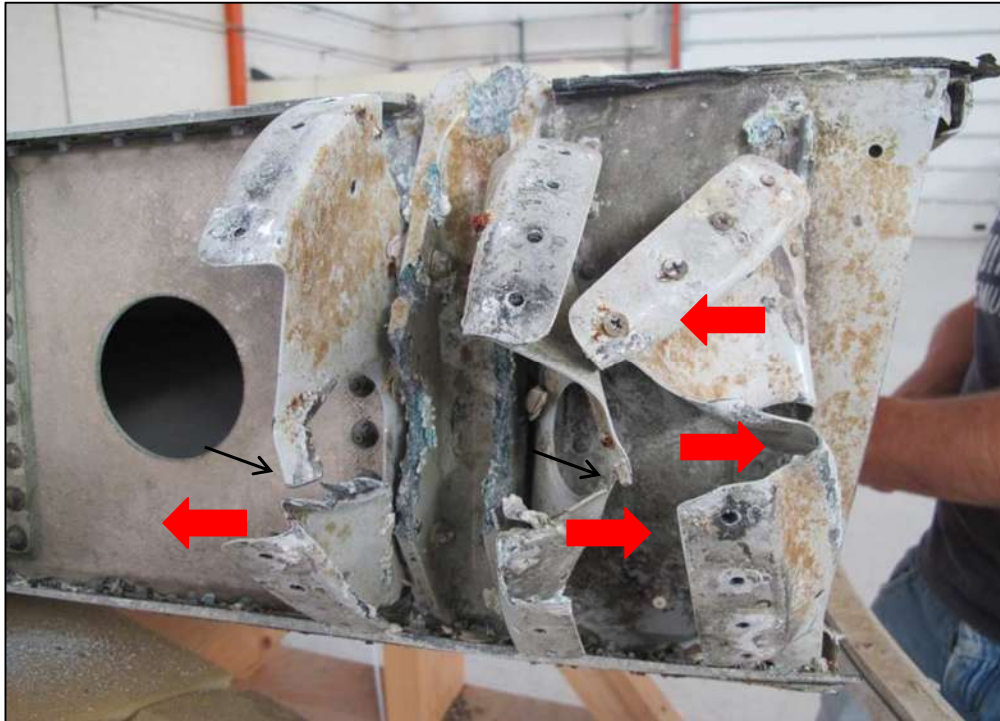
Planche 24 : Hinge fitting on the outboard side

Direction of distortions on rib
tears

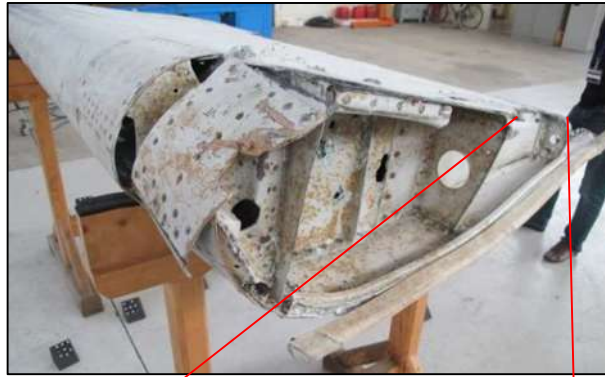
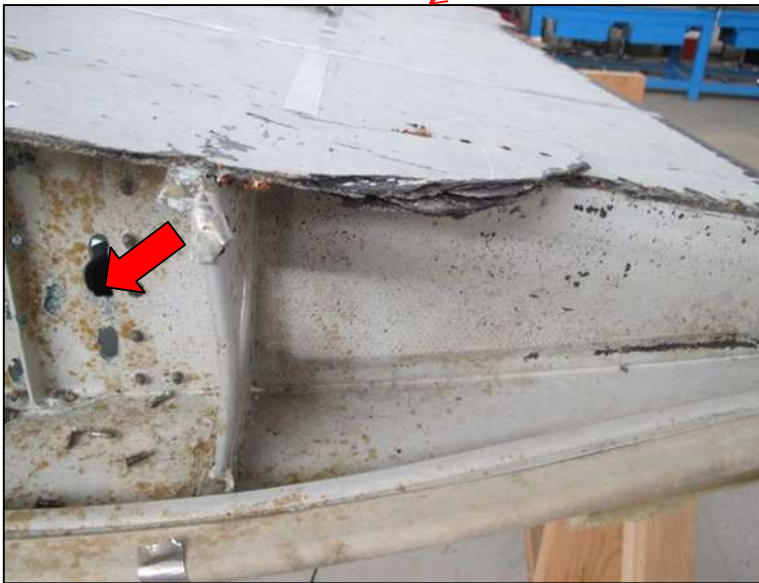
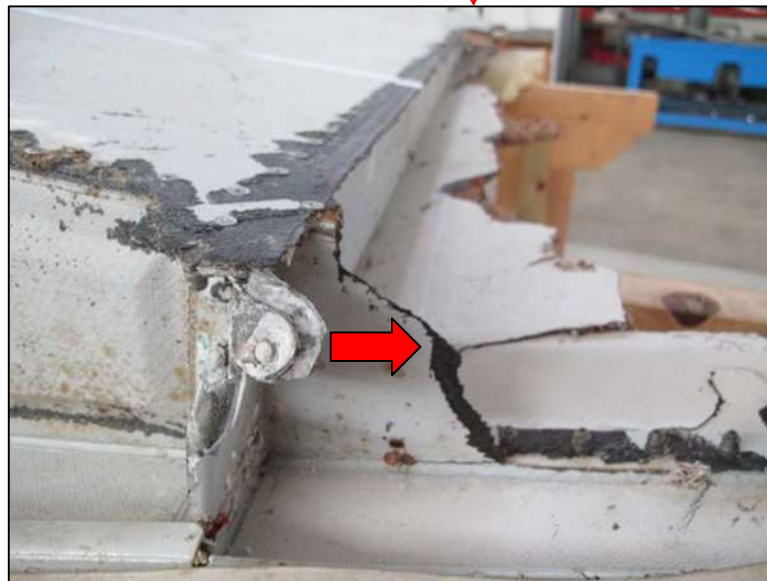
Planche 25 : Elements located aft of the outboard hinge fitting

Direction of distortions

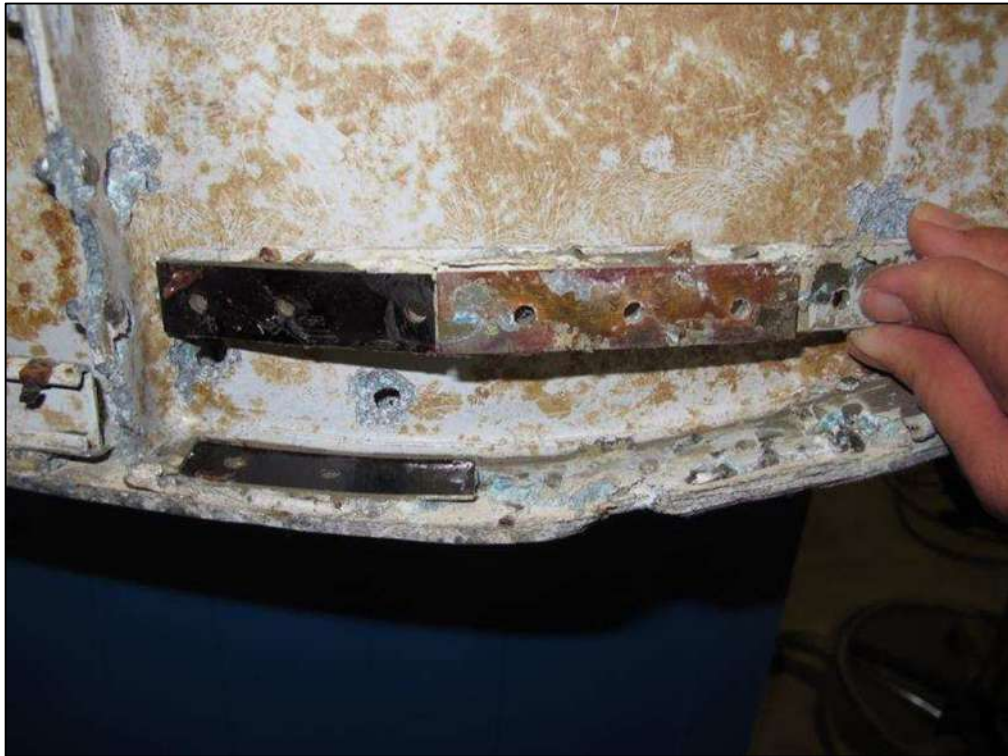
Repair: disassembly of seal retainer

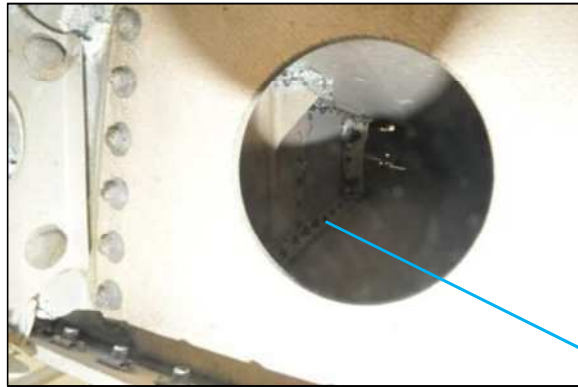
Planche 36 : Flaperon after disassembly of the hinge fitting on the inboard side

**Lower surface side hinge
fitting fracture**

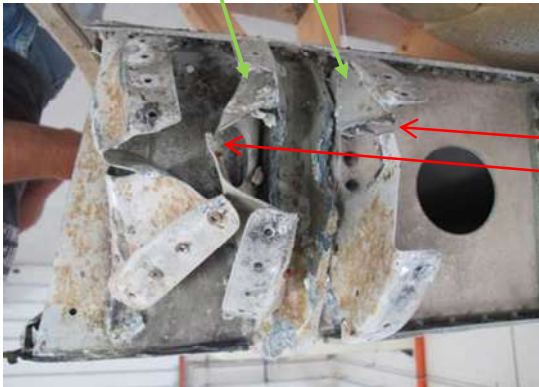
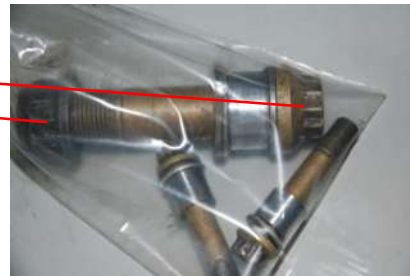
Planche 44 : **Possible explanation of the distortions and fractures of the outboard side leading edge ribs**

Activator hinge point pin and other attachments

The damage to the ribs, especially the tears, seemed to be due to the activator hinge point pin tips.

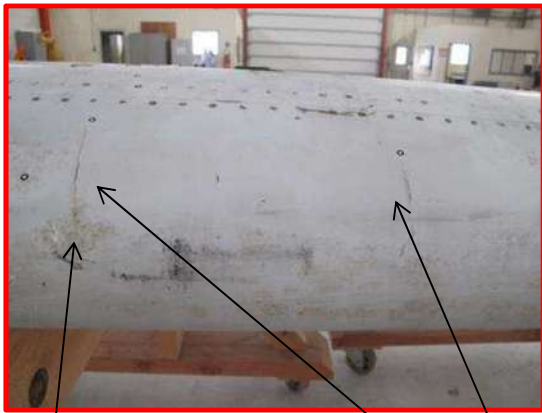
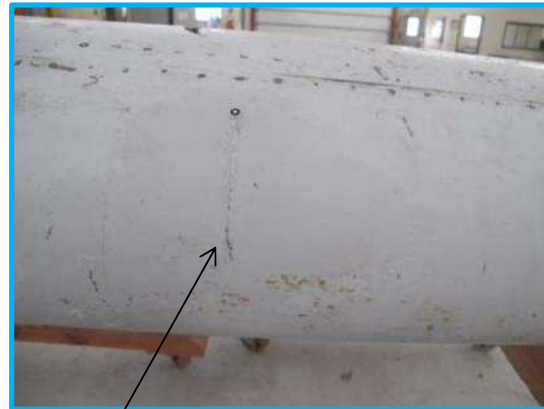
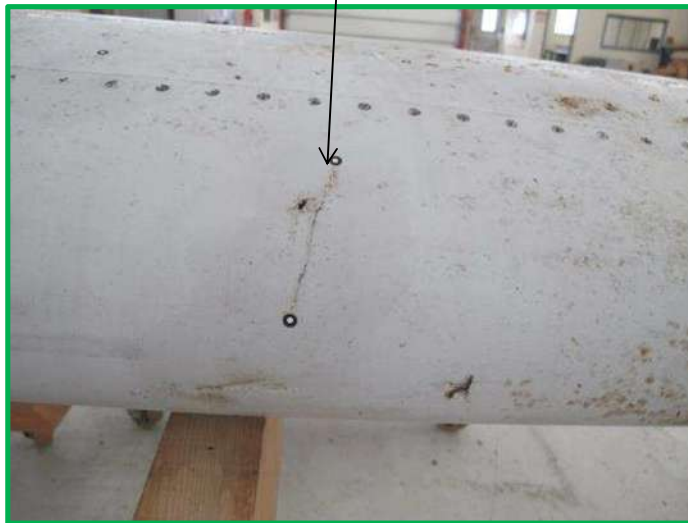
Planche 47 : Impacts on the leading edge

Dent

Vertical cracks

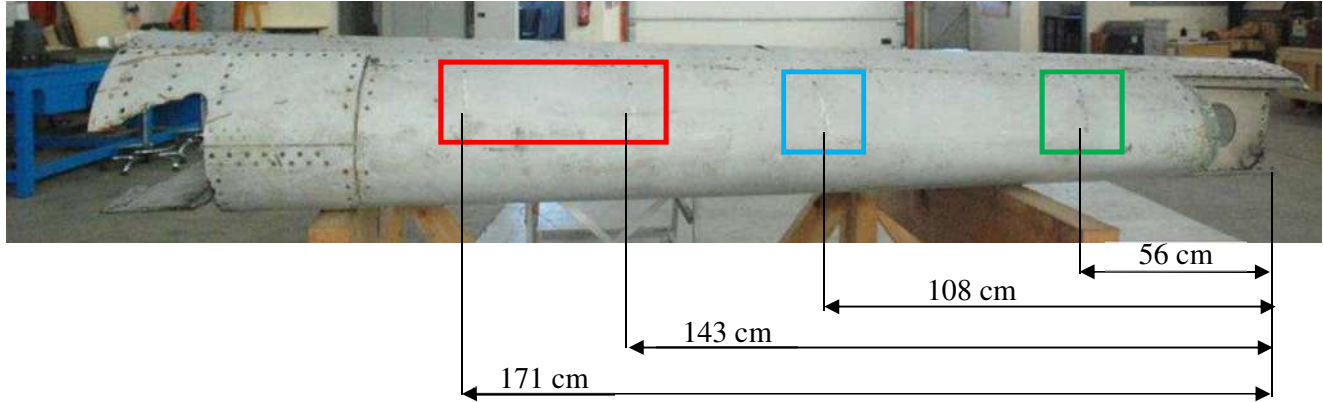
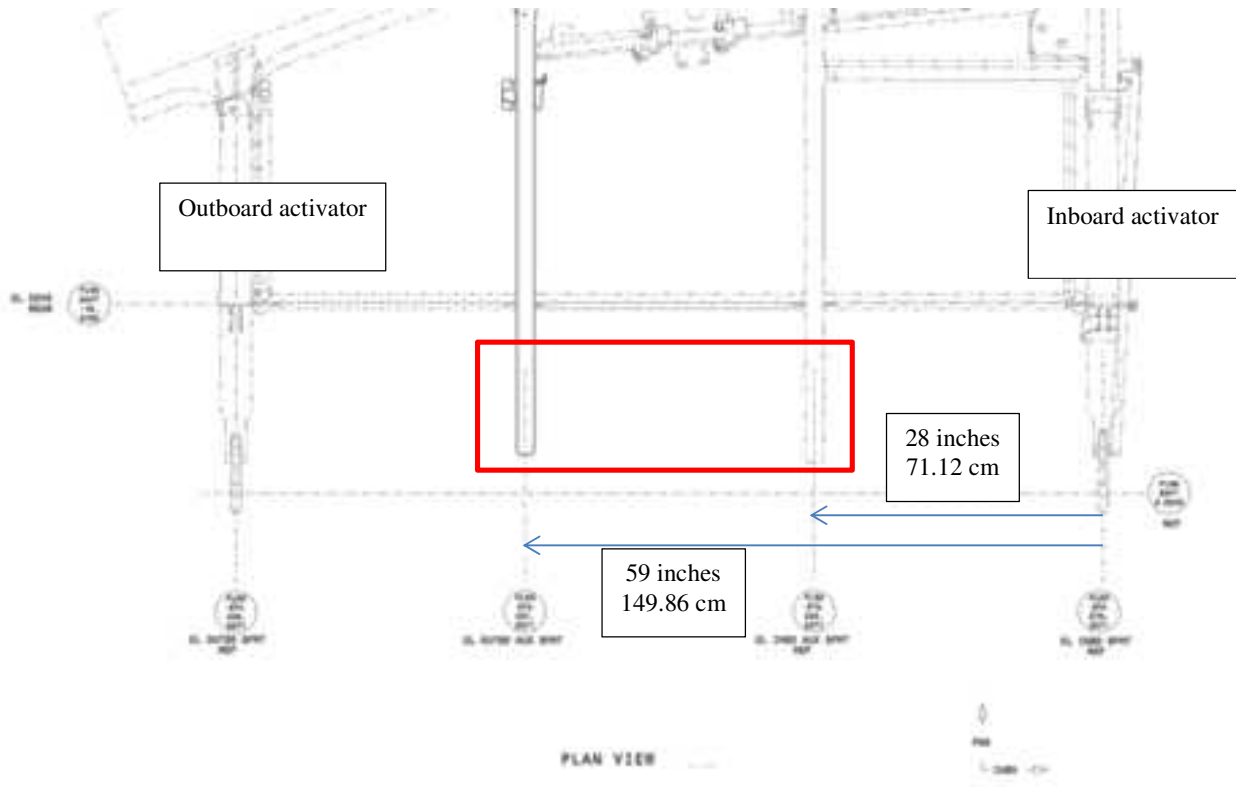
Planche 48 : Comparison of the impacts with the facing wing panel

Only two parts facing according to the parts supplied by Boeing

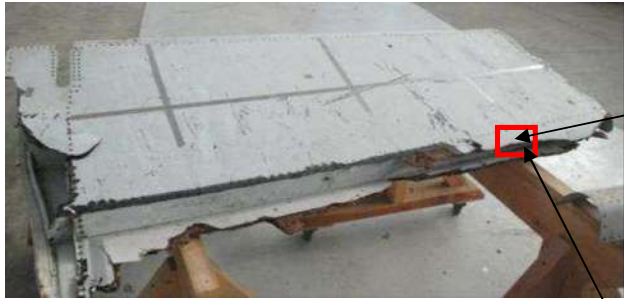
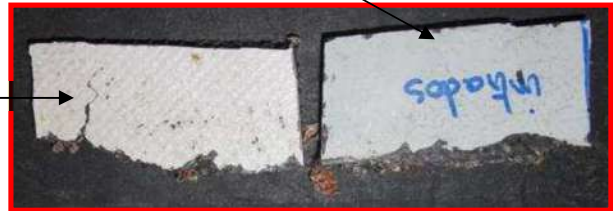
Planche 51 : Lower surface: irregular fracture on trailing edge – SEM Examination

Inner skin : radiating form characteristic of a traction fracture

Inner skin: steps characteristic of a compression fracture

All of the fracture surfaces on the inner skin: majority in compression

All of the fracture surfaces on the outer skin: majority in traction.

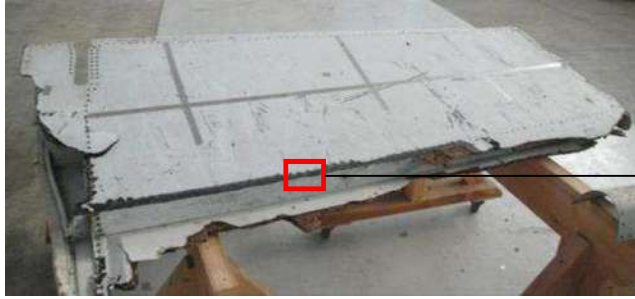
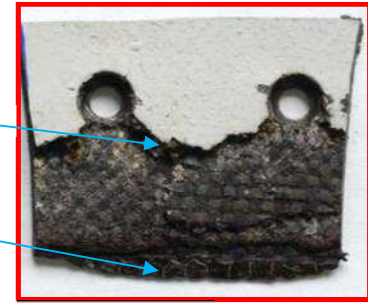
Planche 53 : Lower surface: straight fracture on trailing edge – SEM Examination

All of the fracture surfaces on the upper surfaces: majority in compression.

Upper layers : steps characteristic of a compression fracture

Lower layers: radiating form characteristic of a traction fracture

All of the fracture surfaces on the lower surfaces: majority in compression.

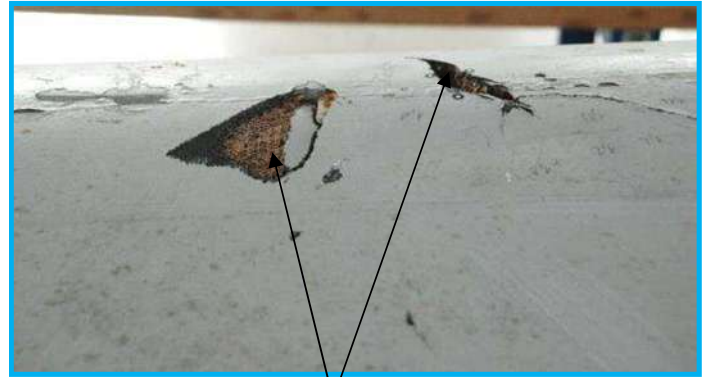
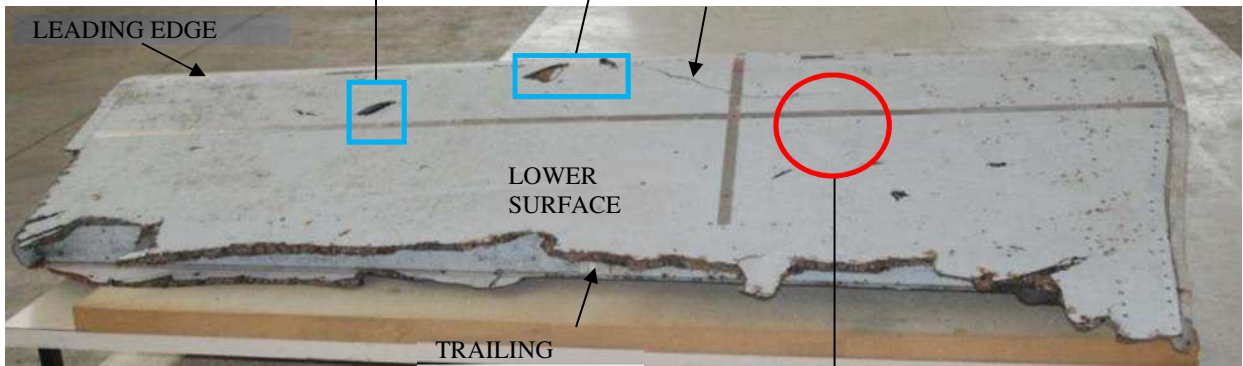
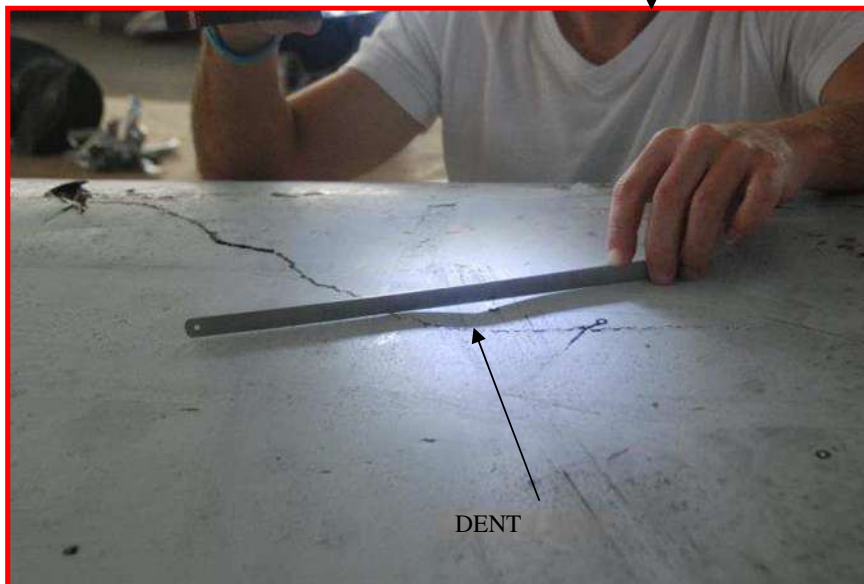
Planche 54 : Upper surface: dents, impacts, crack

Impact

Impacts

DENT

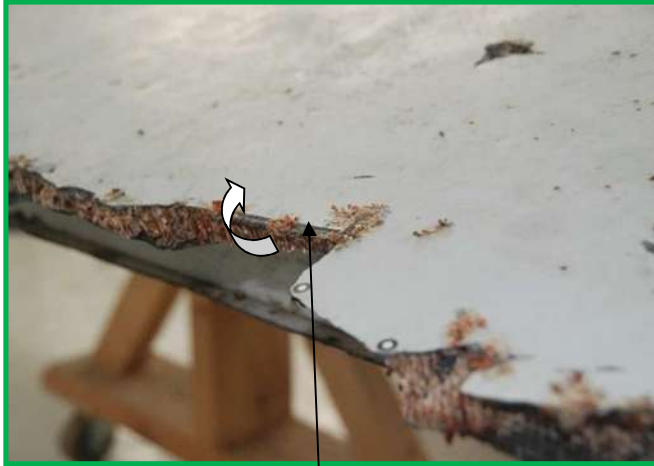
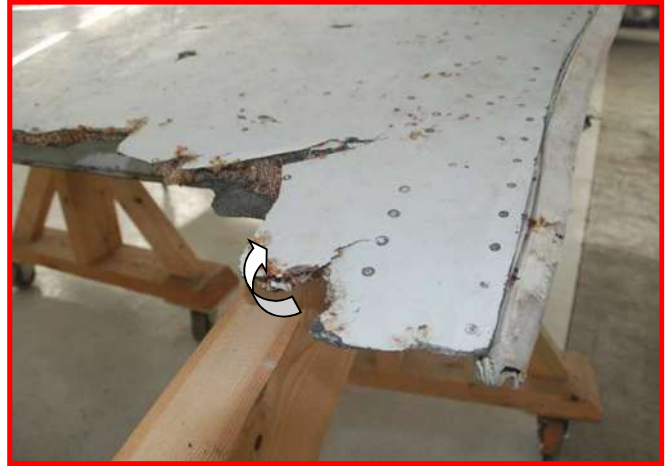
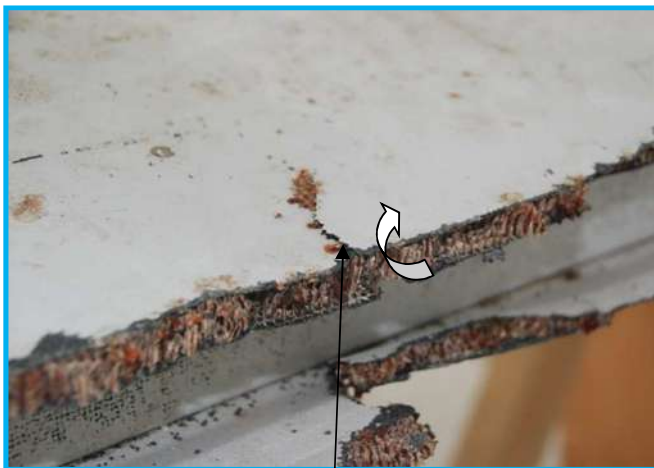
Planche 55 : Upper surface: fracture on trailing edge

Orientation of material upwards

Regular fracture, without protruding fibres

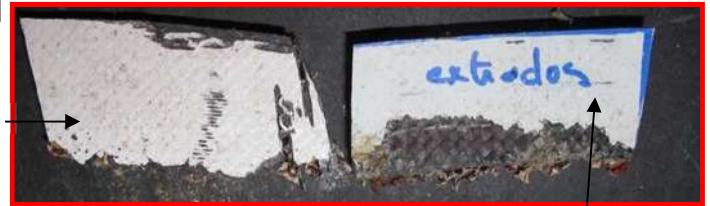
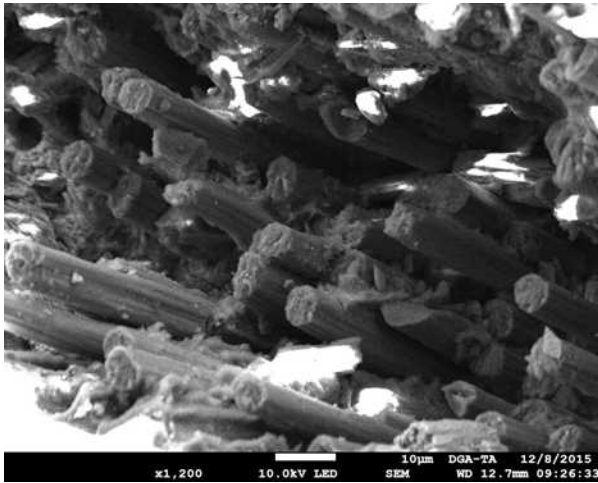
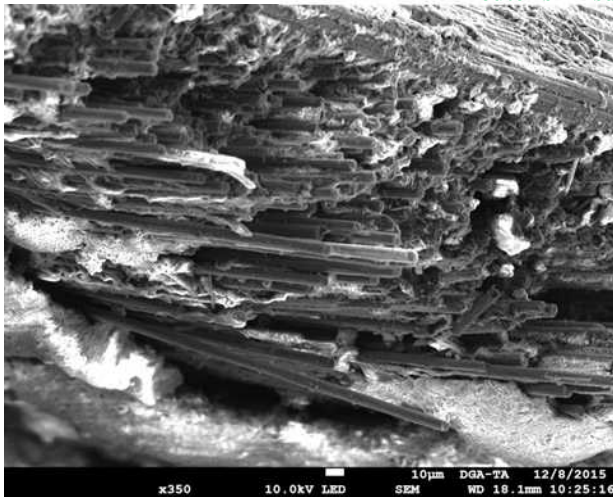
Planche 56 : Upper surface: fracture on trailing edge – SEM examination

Inner skin : surfaces characteristic of a traction fracture

All inner skin surfaces : majority in traction.

All outer skin surfaces : majority in traction.

Outer skin : surfaces characteristic of a traction fracture

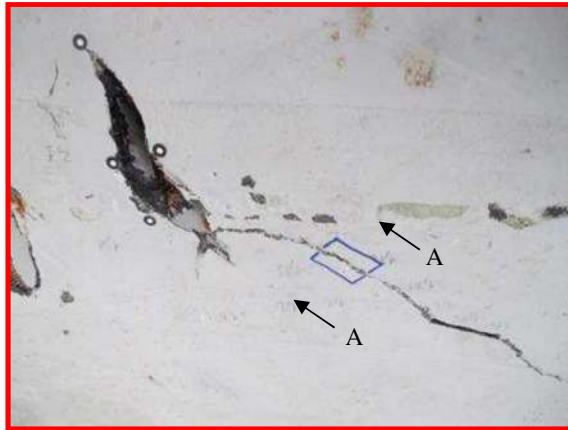
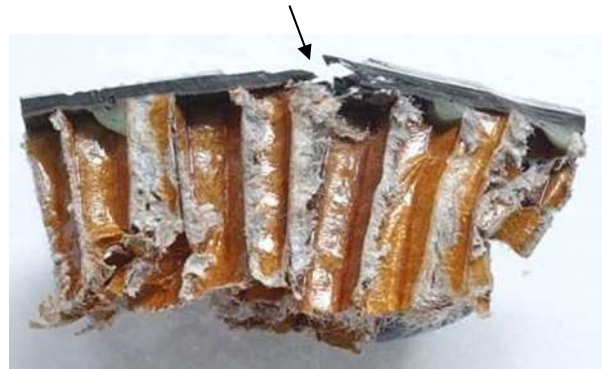
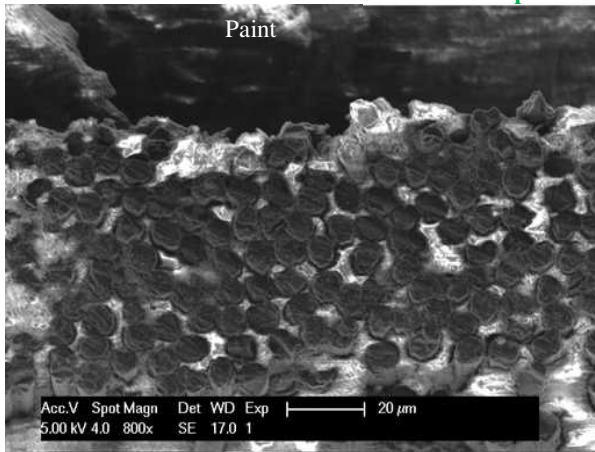
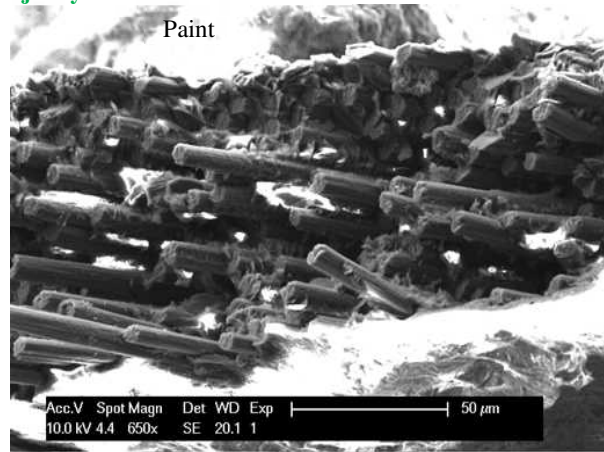
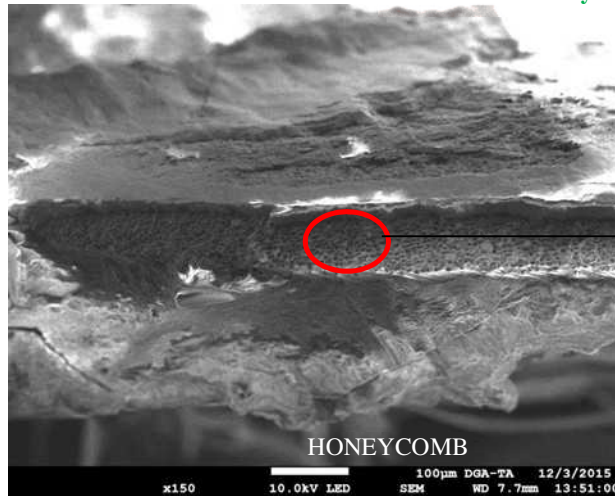
Planche 58 : **Upper surface: observation of the crack in a non-protruding part**

Macroscopically : bending fracture of outer skin

All surfaces paint side : majority in traction.

Near paint : steps characteristic of compression fracture

Near paint : surfaces characteristic of traction fracture

All surfaces honeycomb side: majority in compression.

Near honeycomb : steps characteristic of compression fracture

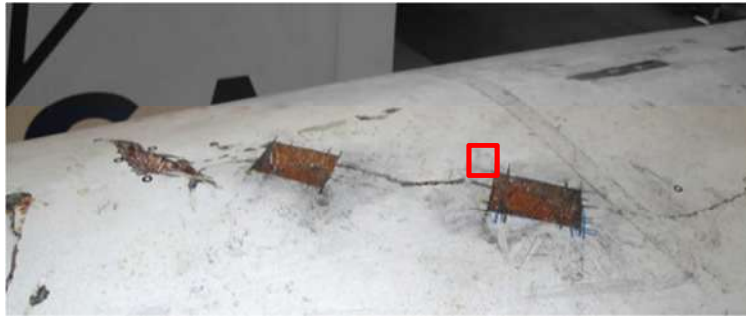
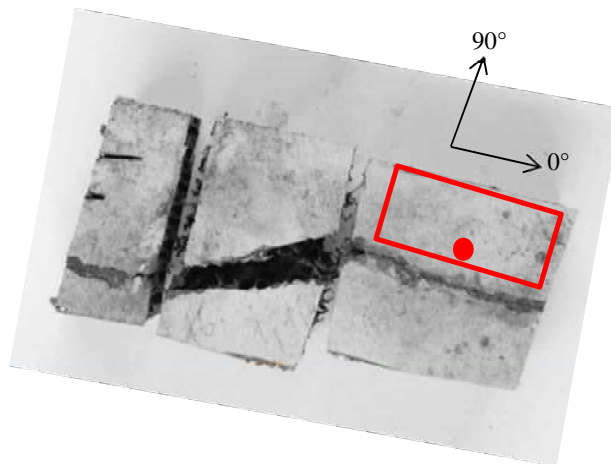
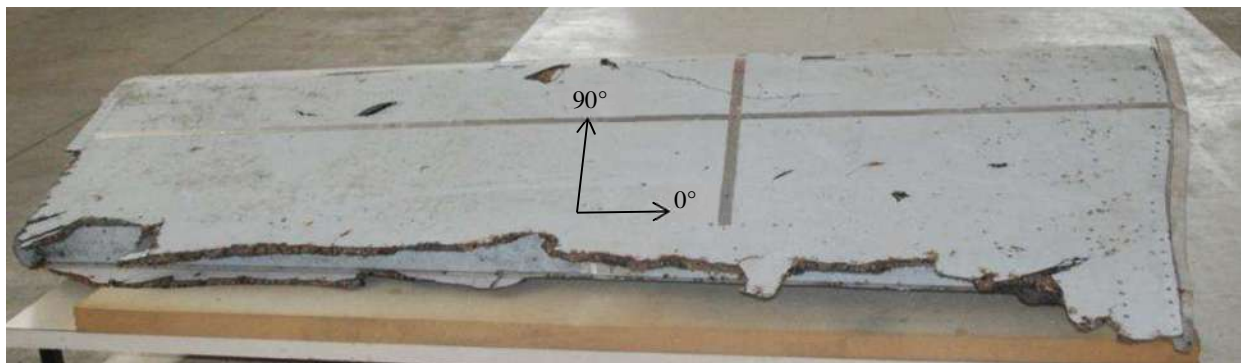
Planche 59 : Upper surface: orientation of outer skin folds

The outer skin consists of three folds, the orientation above is in relation to the crack.

In the flaperon referential, see above, the following draping appears: +/-45°,0/90°,+/-45°.

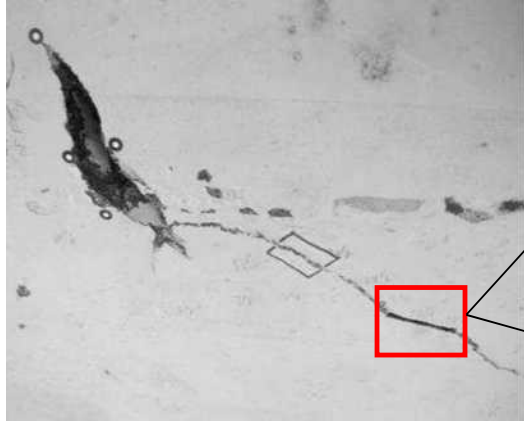
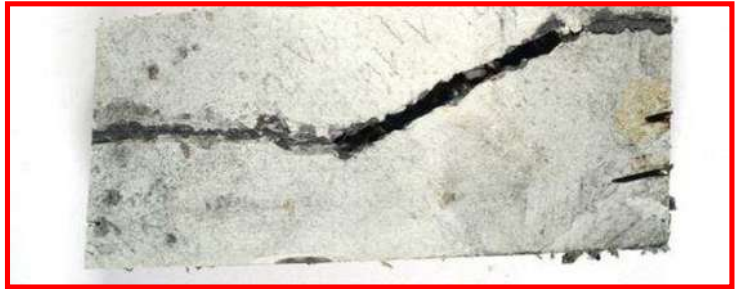
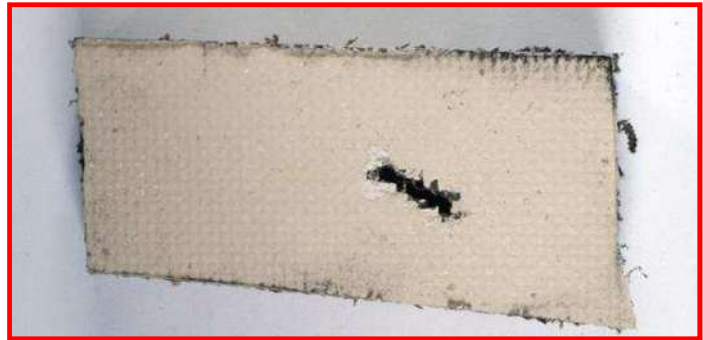
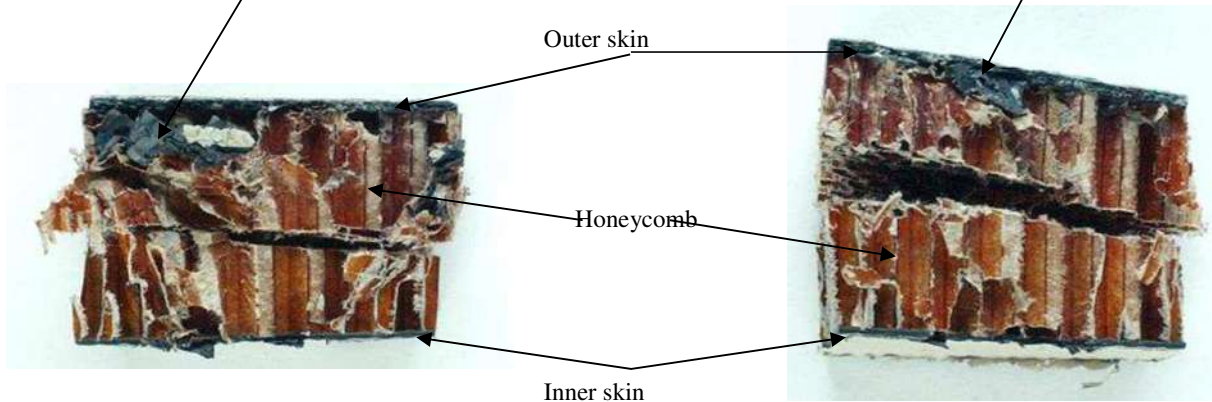
Upper surface: observation of the crack in a protruding part (1/2)

Downwards orientation of material

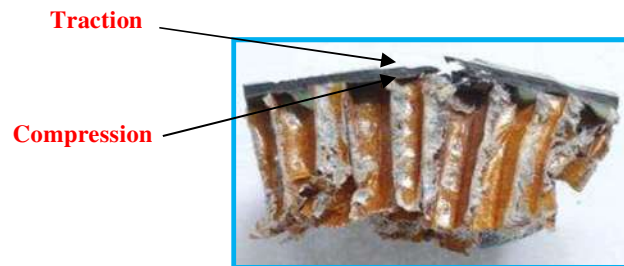
Planche 62 : Summary of the deductions made based on the observations and examinations on the composite structure of the flaperon

Non-protruding crack : **bending**
fracture : **skin bowing.**
